Active
Building
Centre

Stroud District Council

Zero Carbon Public Estate programme

Building Performance Evaluation Report

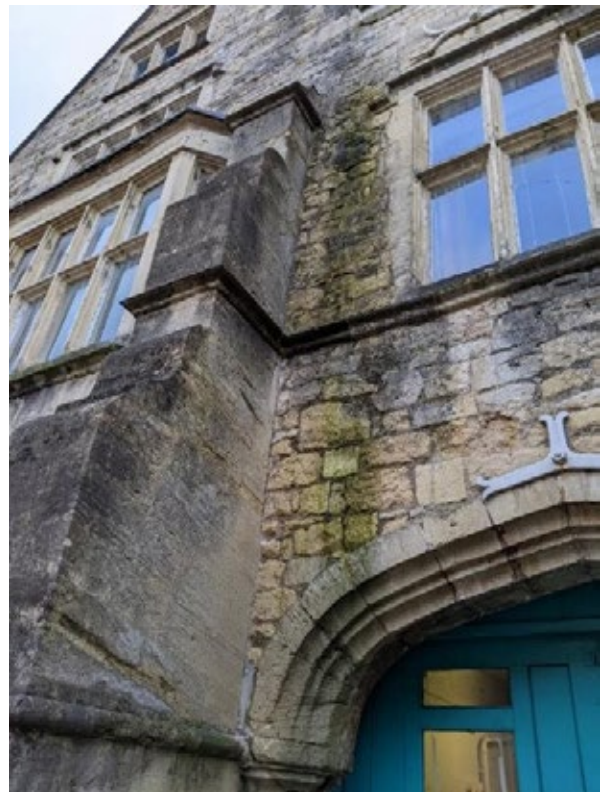
Figure 14 illustrates the crack that runs from the parapet down to entrance door for the ground floor office on the front facade. There is extensive water staining on the stonework on the front of the building, evident in Figures 17 to 19 and Figure 21. Figures 20 through to 23 and 27 show vegetation growth, which appears to be in the stonework and the gutter in Figure 21.

Figure 19: Top of right buttress when facing the building

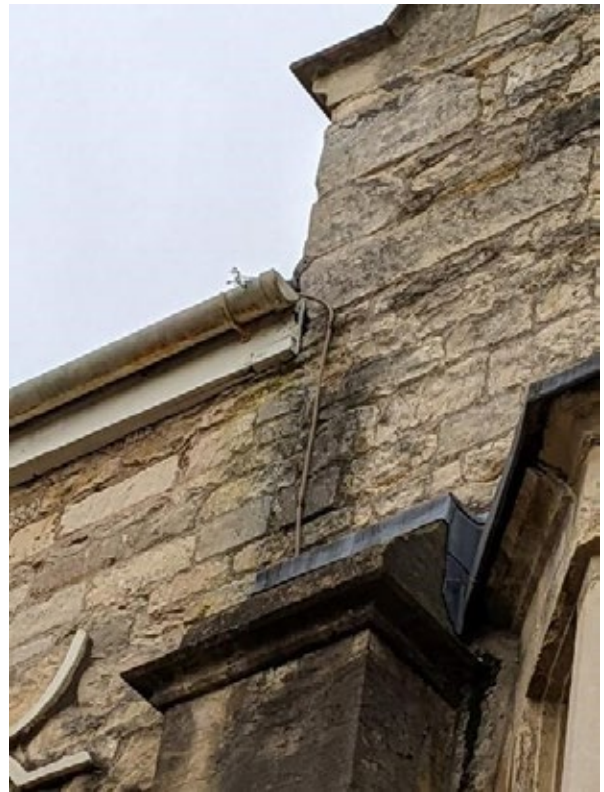
Vegetation growth indicates high moisture content and can damage mortar joints, allowing water ingress. For the gutter, it can block rainwater run-off and cause it to overflow and run down the surface of the wall. Excess water on the surface of the wall, illustrated by staining, can increase the risk of water ingress into the internal surface.

Figure 21: Corroded guttering, vegetation growth and staining at front of the building

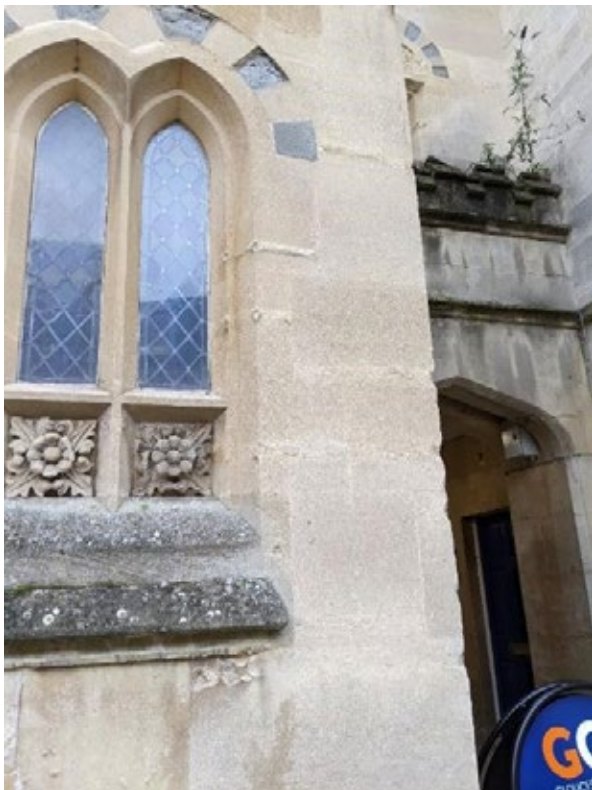
Figures 22 and 23 illustrate some blistering and delamination of the stonework, and mortar joint decay. This could indicate that the embedded iron cramps are corroded and therefore expanding. Additionally, there appears to be some salt crystallisation.

Figure 22: Blistering and delaminating stonework at the front of the building (near archway)

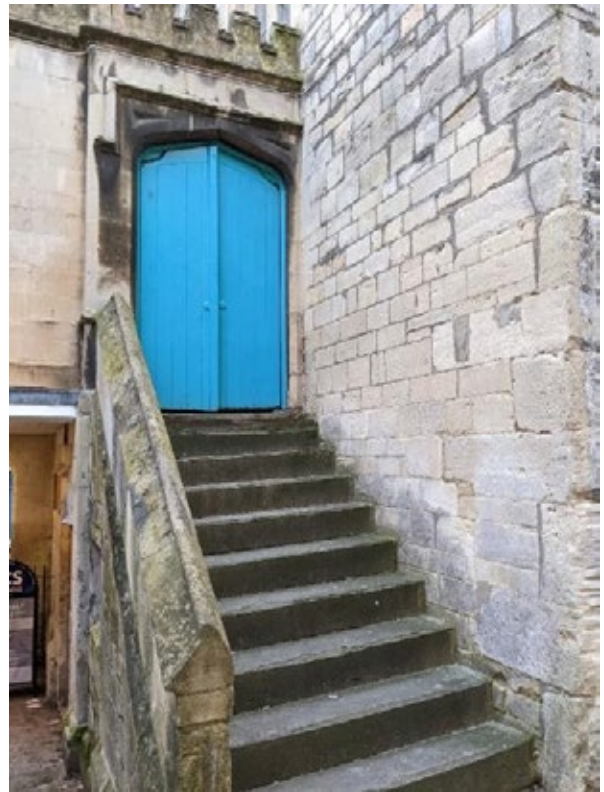
Figures 28 and 29 illustrate pointing in the stonework that appears to be cement based. Figure 33 illustrates water staining on the rear wall. Figures 34 and 35 illustrate further vegetation growth on the north wall, facing the Church. **The general condition of the external areas is satisfactory to poor, with areas that are very poor.**

Figure 29: Steps and exist from corridor between first floor meeting room and kitchen

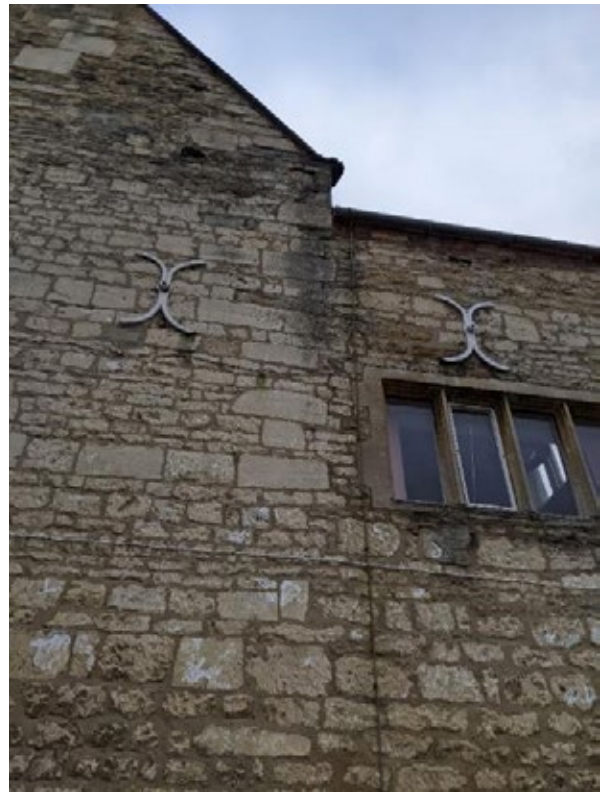
Figure 33: Rear wall of original 16th Century part of building

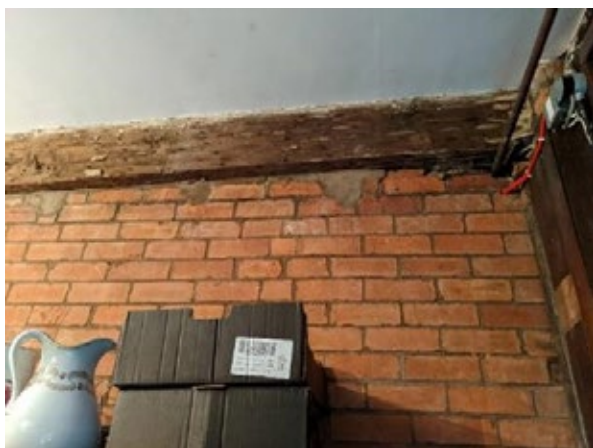
It was difficult to see many surfaces in Store 1 due to the quantity of items being stored. The brick wall in Figure 36 is stretcher bond, indicating it could be single skin. The bricks are also relatively modern. The timber beam in Figure 37 shows some signs of decay.

Figure 36: Partition wall

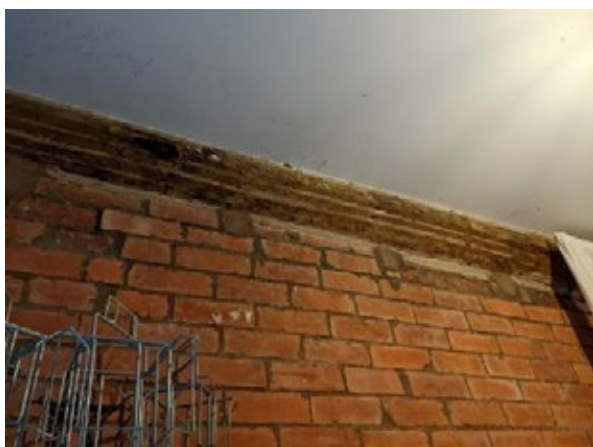
As for Store 1, it was also difficult to see surfaces in Store 2 due to the quantity of items being stored. Figure 38 is the other side of the wall shown in Figure 36 above. Figure 39 is the other partition wall. It is a solid wall with a mix of Flemish and common brick bond. The mortar joints appear to be in relatively poor condition.

Figure 38: Partition wall

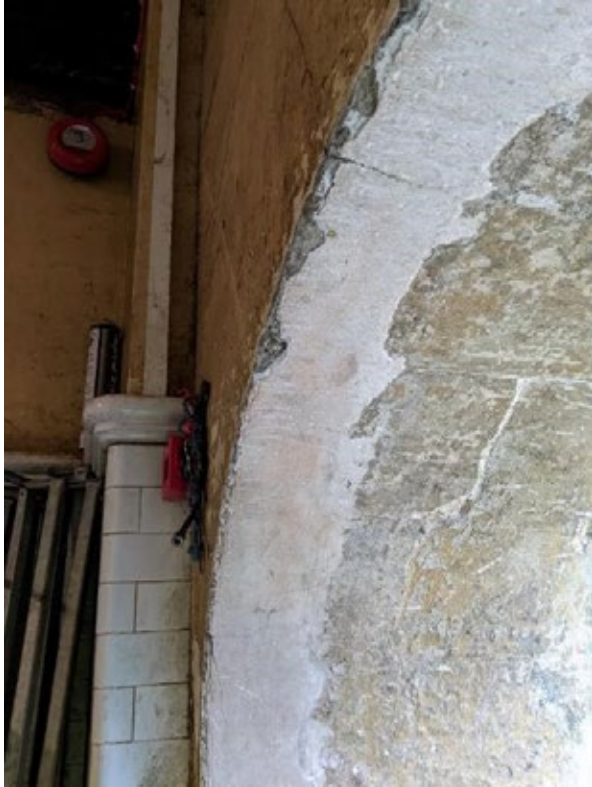
Figures 43 to 46 show the entrance to store 3. The photographs illustrate the apparent use of cement from previous repairs to the stone frame entrance.

Figure 43: Entrance to Store 3

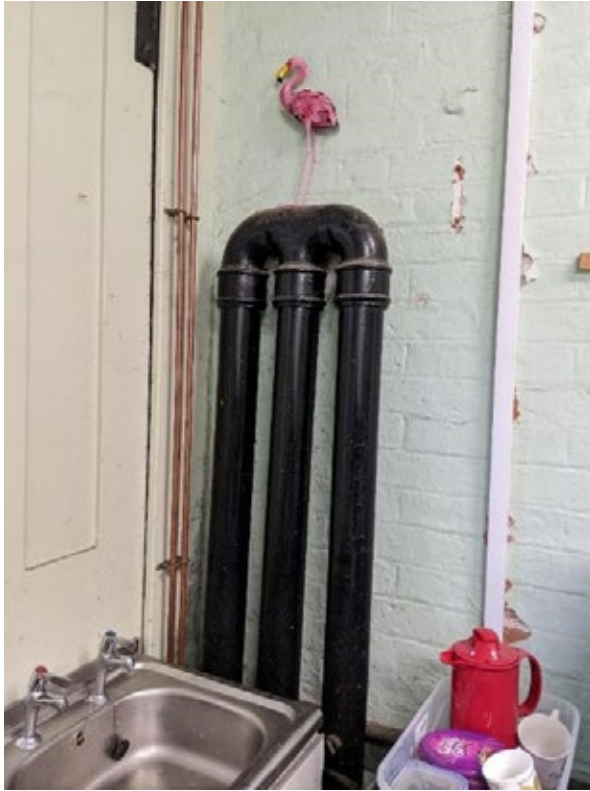
There are several services in this store, including hot and cold water, waste pipes and electricity, most of which can be seen in Figure 47. Three of the walls in this store appear to have been covered with gypsum plaster and all four have been painted with an impervious paint. Figures 48 to 50 illustrate evidence of salt crystallisation, blistering and delamination within the plaster, which is consistent with moisture penetration. Figures 51 and 52 show the timber beam, which appears to have been subjected to severe decay.

Figure 47: Services in Store 4

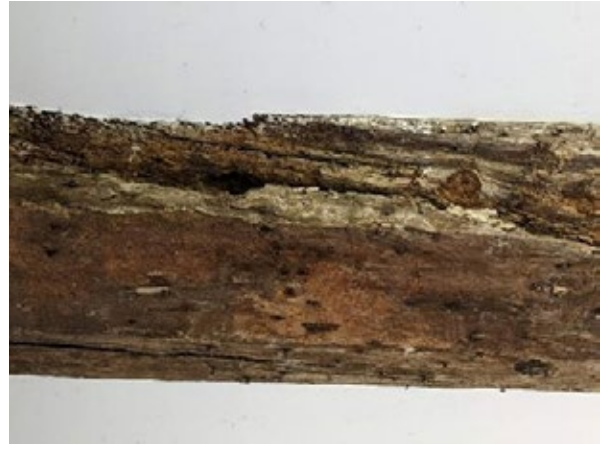
Figure 52: Evidence of timber decay

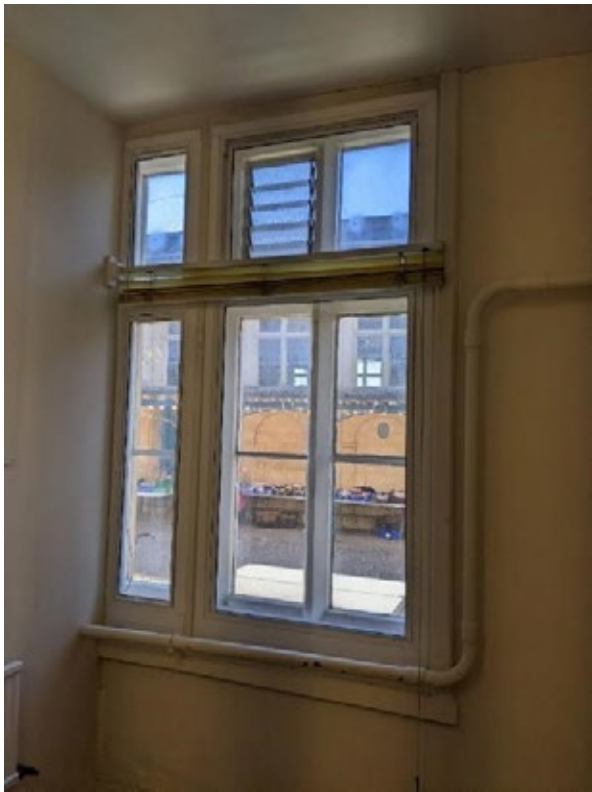
There is a large window with a louvred pane in the top centre casement (Figure 53). This appears to be the only access to natural ventilation. **However, the window has secondary glazing, which does not appear to be openable.** If the secondary glazing is not openable then access to the openable window and louvred pane will not be possible. **There is a crack in the wall and ceiling** (Figure 54).

Figure 53: Window in GF Office 1

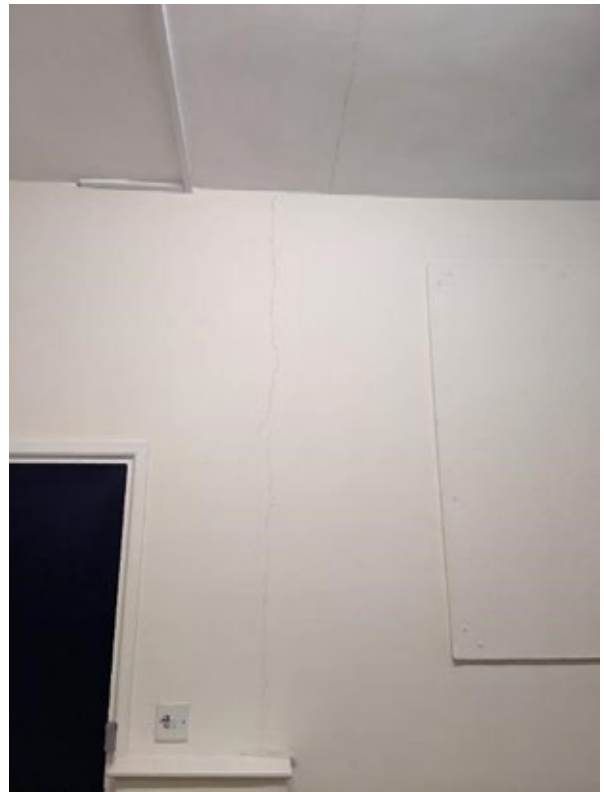
Figure 54: Crack in wall and ceiling in GF Office 1

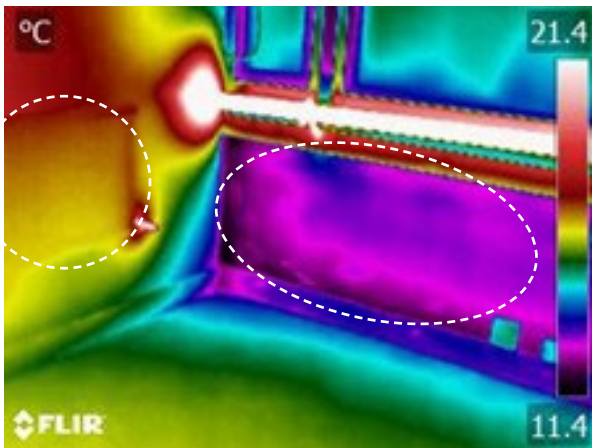
The radiator appears to have been turned down due to the room being unoccupied (see Figures 55 and 56). However, the large bore central heating pipe travels through the room to provide space heating to Office 2 and 3 on the other side of the wall. **The heat being emitted from this un-lagged pipe appears to be significant** (Figures 55 and 57). Despite this apparent heat gain, the internal temperature is low at below 15°C. This is likely to be due to the heat loss through the window, in particular the louvre (Figure 53), the wall below the window (Figures 55 and 56), and the vent in the top right corner (Figures 57 and 58). **The general condition of GF Office 1 is poor.**

Figure 55: IR image showing wall under window in GF Office 1

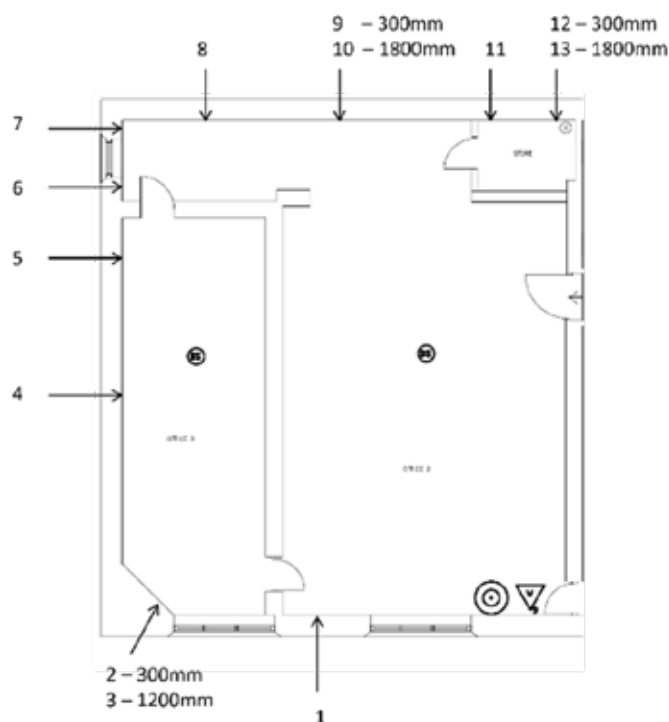
Table 3: Moisture readings for GF Office 2 and 3, and adjoining spaces (store is used as kitchenette)

The moisture readings were recorded according to the locations set out in Table 4 below. The readings indicate that there is potential water ingress in the walls. The readings in locations 6 to 11 and 13 could be lower due to the dry lining that is on these walls (see below in reference to Figures 75 and 77). Location 12 could be where the adhesive is bridging between the existing wall and the plasterboard lining. **These high moisture readings require further investigation.**

Location Tag	1	2	3	4	5	6	7
Moisture Reading	100%	65%	44.3%	66.7%	55.2%	37%	28%
Location Tag	8	9	10	11	12	13	-
Moisture Reading	33.6%	31.8%	100%	34.2%	87.5%	26%	-

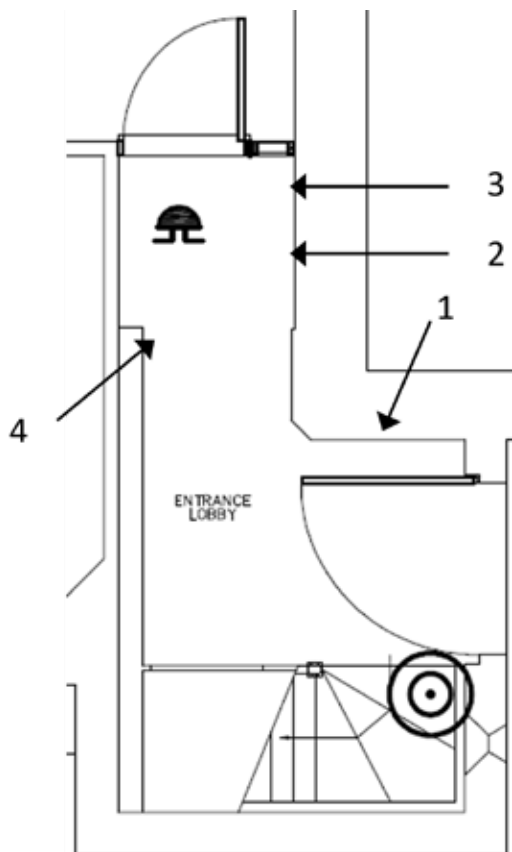
Table 4: Moisture readings for GF entrance lobby

The moisture readings were recorded according to the locations set out in Table 5 below. The readings indicate that there is potential water ingress in the walls. The readings in all locations are very high. The addition of a solid concrete floor could be a contributory factor for these high readings as this is forcing ground moisture up the walls, where it cannot escape due to the impervious gypsum plaster and paint covering. **These high moisture readings require further investigation.**

Location Tag	1	2	3	4
Moisture Reading	95.3%	91.1%	100%	73.5%

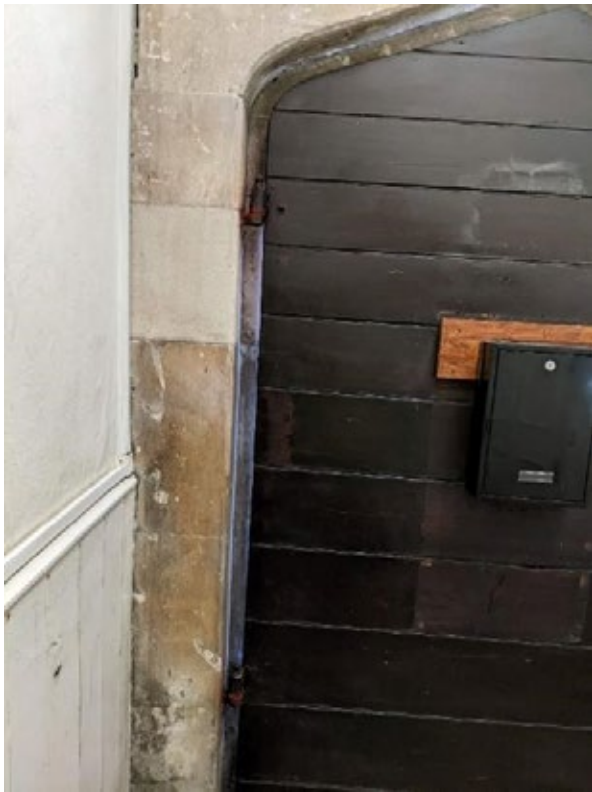
The main entrance door to the building is solid wood in a stone frame. **There are large gaps around the door**, illustrated by the visibility of light when the door is closed. The floor is tiled and there is timber panelling on the wall behind the door. **There is significant decay of the timber skirting** below the timber panelling and behind where it should be fixed to the wall. The decay is consistent with the high moisture readings. **The general condition of the GF entrance lobby is satisfactory to poor, with areas that are very poor.**

Figure 79: Main entrance door

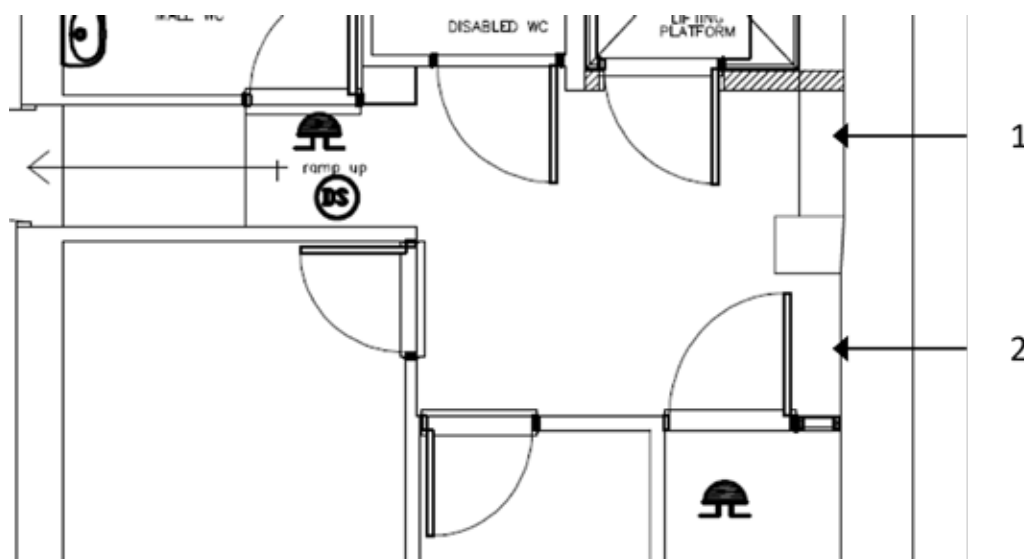
Table 5: Moisture readings for GF circulation space

The moisture readings were recorded according to the locations set out in Table 6 below. The readings indicate that there is potential water ingress in the wall closest to the entrance lobby (location 2). The reading in this location is very high. As with the entrance lobby, the addition of a solid concrete floor could be a contributory factor for this high reading as this is forcing ground moisture up the walls, where it cannot escape due to the impervious gypsum plaster and paint covering. **These high moisture readings require further investigation.**

Location Tag	1	2
Moisture Tag	30.6%	100%

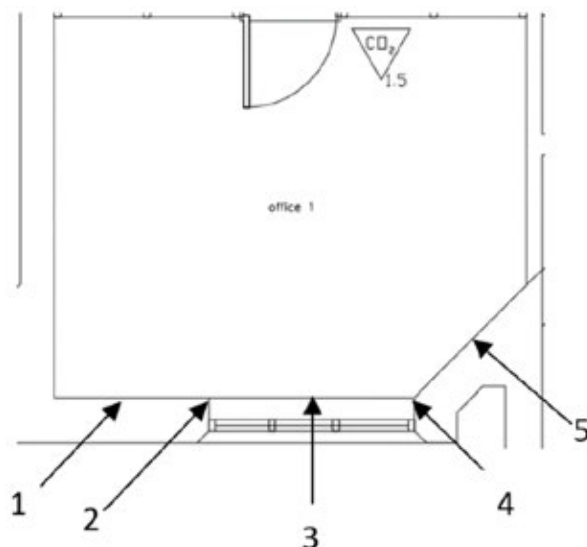
Table 6: Moisture readings for FF Office 1

The moisture readings were recorded according to the locations set out in Table 7 below. The readings indicate high levels of moisture in the external walls and in the chimney breast wall.

Location Tag	1	2	3	4	5
Moisture Reading	30.3%	57.4%	31.5%	64.8%	42.4%

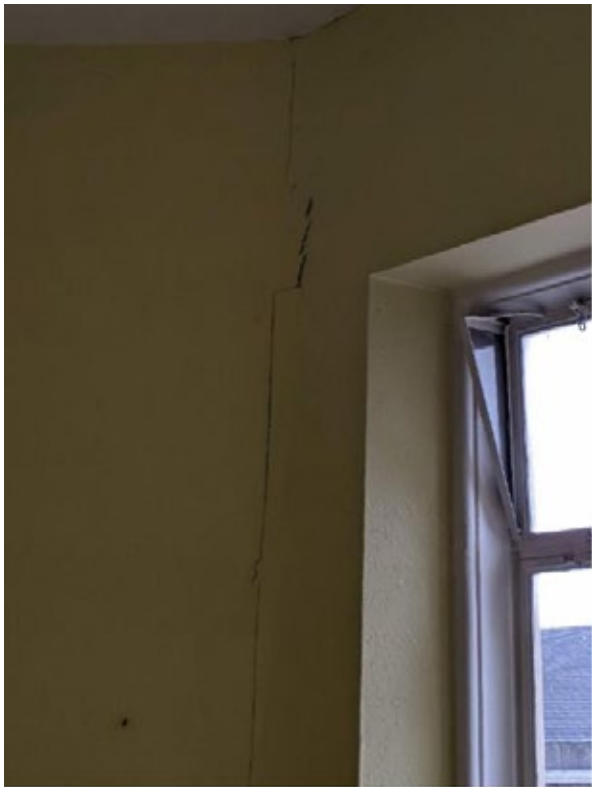
There is a vertical crack at the junction between the external wall and the chimney breast (Figure 83). There is significant heat transmission evident in the thermal image (Figure 91). The flue pipe for the boilers in the plant room below FF Office 1 is in the chimney breast. On the opposite side to the chimney breast are diagonal cracks with heat being transmitted through them (Figures 89 and 90). This is consistent with the location of the vertical crack visible on the front façade of the building, identified in Figure 14 above. There was also some movement under foot when walking across the floor, in the corner where there are diagonal cracks in the wall. There are gaps under the skirting at the bottom of the external wall and the partition wall. These gaps are allowing heat transmission, possibly from heating pipes under the floor. **A structural investigation should be undertaken to examine this further. The general condition of FF Office 1 is poor.**

Figure 87: Vertical crack at junction between external wall and chimney breast

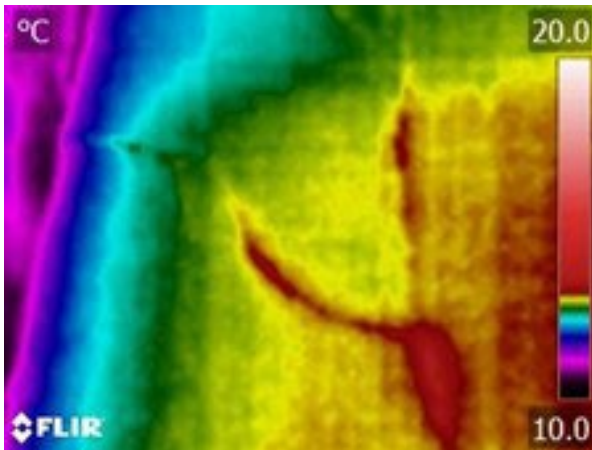
Figure 89: IR image showing heat transmission through diagonal cracks in wall

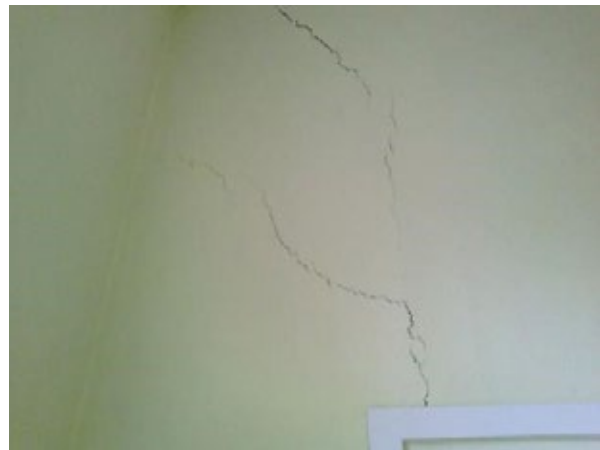
Figure 90: Photograph showing diagonal cracks in wall

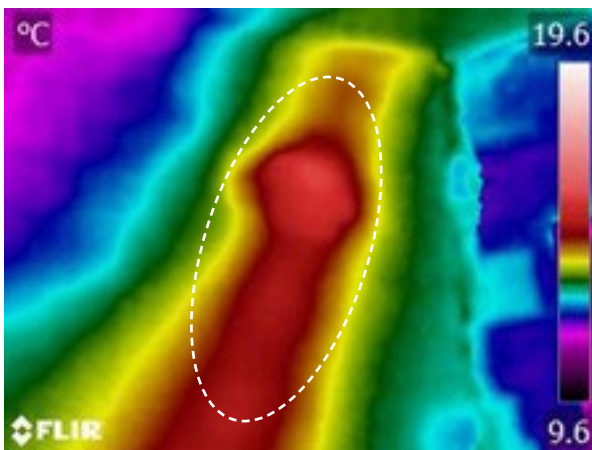
Figure 91: IR image showing heat transmission in chimney breast

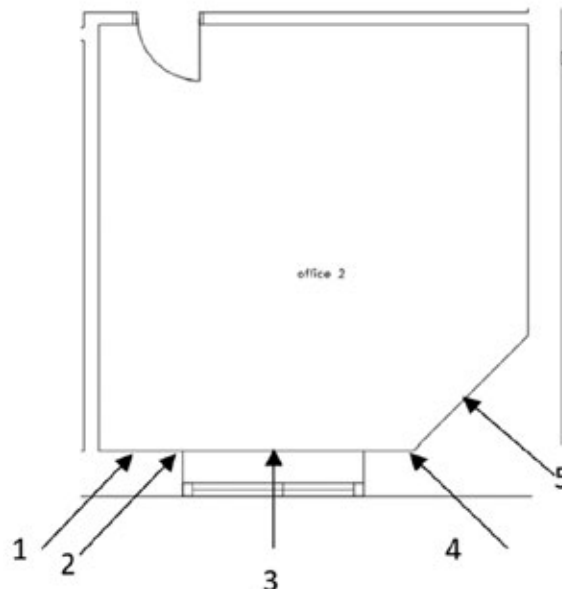
Table 7: Moisture readings for FF Office 2

Location Tag	1	2	3	4	5
Moisture Reading	28%	25.3%	25.3%	24.2%	40.1%

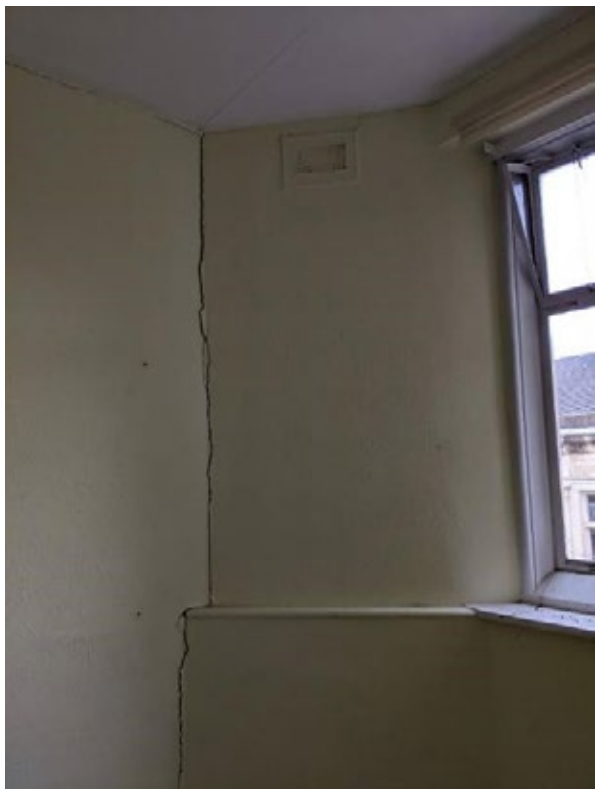
There is vertical crack between the partition wall and chimney breast (Figure 95). There is also a vertical crack in the corner between the partition wall for Office 1 and the corridor (Figure 96). Heat transmission can be seen in the location of the crack (Figures 99 and 100). **The cause of these cracks should be investigated by a Structural Engineer.** There are holes in the partition walls, which has exposed their structure (Figures 97 and 98). The partition walls appear to have been constructed using laths and lime plaster. The walls have since received a layer of gypsum plaster. There appears to be **gaps in the roof insulation**, illustrated by the cold spots in Figures 101 and 102. **The general condition of FF Office 2 is very poor.**

Figure 95: Chimney breast in FF Office 2

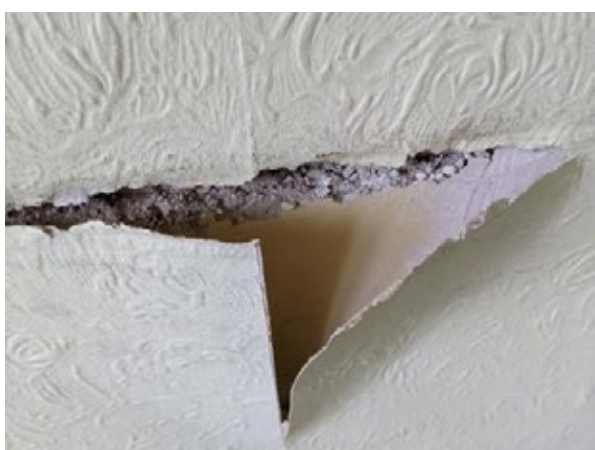
Figure 97: Damaged wall covering and plaster underneath

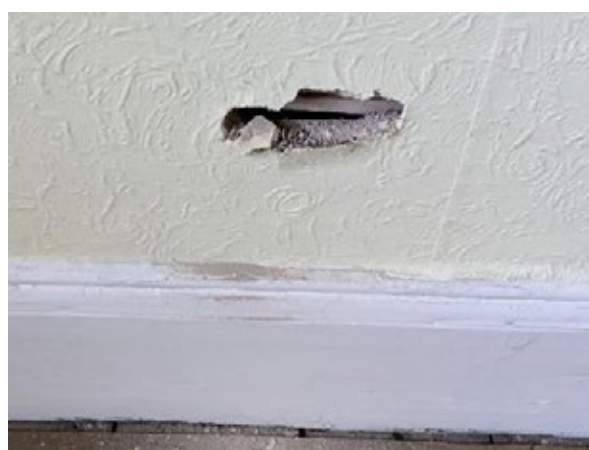
Figure 98: Damaged wall cover and plaster underneath, exposing lathes

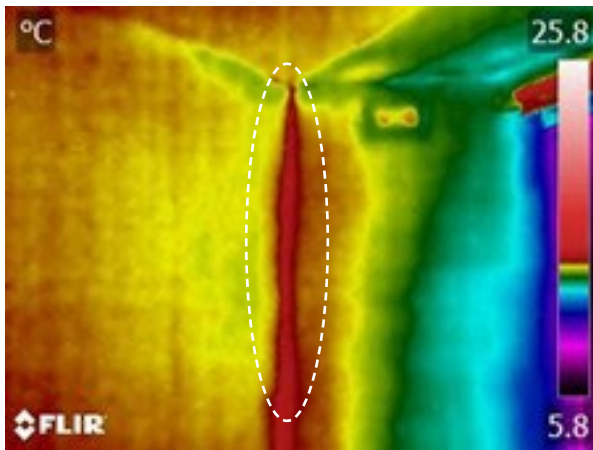
Figure 99: IR image showing heat transmission at junction between chimney breast and partition wall for FF Office 1

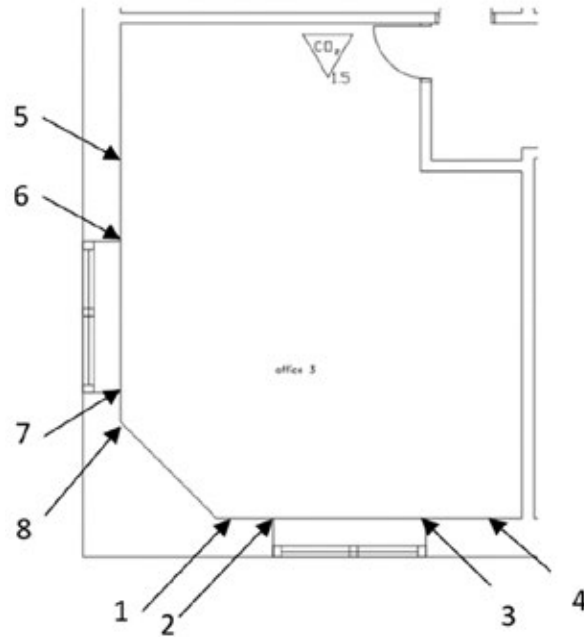
Table 8: Moisture readings for FF Office 3

Location Tag	1	2	3	4	5	6	7	8
Moisture Reading	25.3%	50.2%	39.8%	34%	33.6%	30.9%	30.3%	26.6%

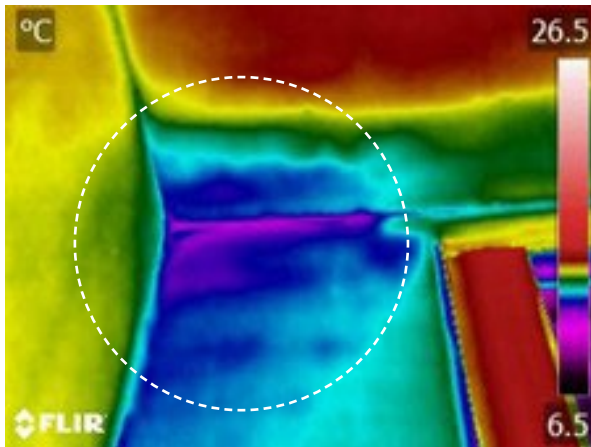
On the external wall at the front of the building, there is a cold area in the corner junction with the roof and the partition wall with Office 2 (Figures 101 and 102). There are several cold spots indicating thermal bridging on the ceiling Figures 103 to 110. **There appears to be gaps in the insulation in the roof, thus requiring further investigation. The general condition of FF Office 3 is satisfactory to poor.**

Figure 101: IR image showing large cold area at junction between roof, north wall and Office 2 partition wall

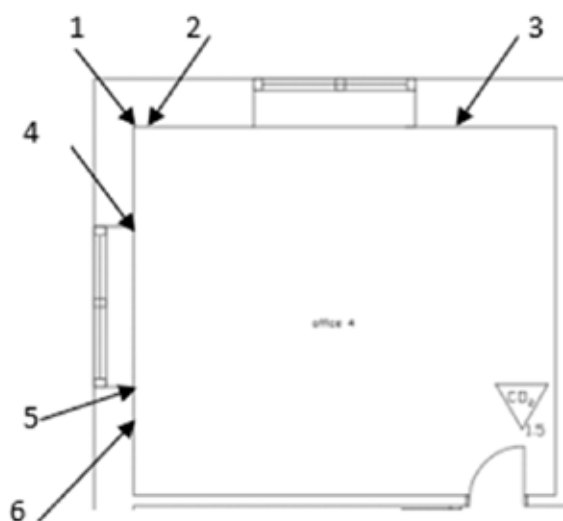
Table 9: Moisture readings for FF Office 4

Location Tag	1	2	3	4	5	6
Moisture Reading	27%	25.8%	44.7%	28%	35%	34.4%

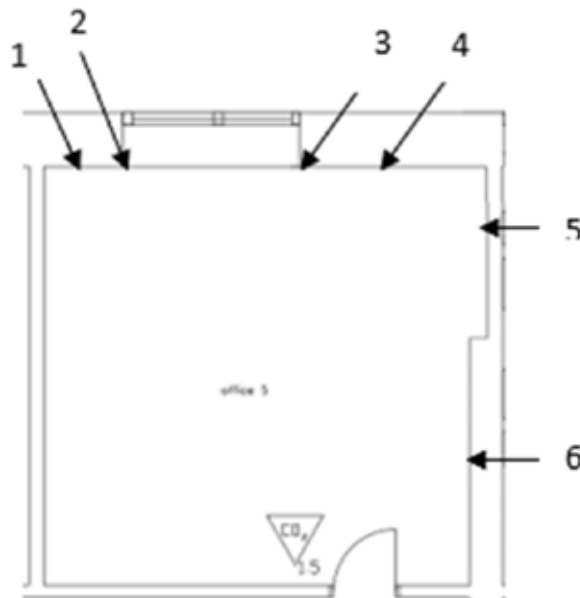
Table 10: Moisture readings for FF Office 5

The moisture readings were recorded according to the locations set out in Table 11 below. As with FF Offices 2, 3 and 4, the readings indicate relatively low moisture levels compared to the readings on the ground floor and FF Office 1. However, they are still considered to be high, compared to recommended levels of less than 16%.

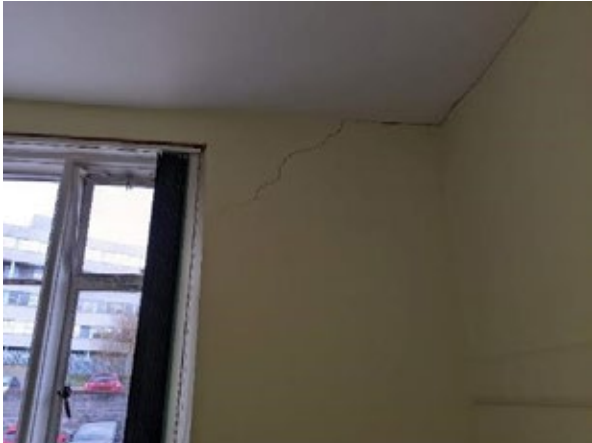
Figure 120: Diagonal crack in wall of FF Office 5

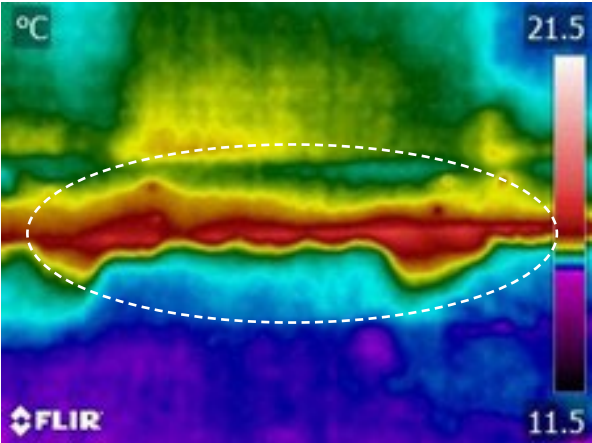
There is heat entering from under the partition wall for the first floor WC (Figures 117 and 118). There are also **gaps in the roof insulation**, evidenced from the cold spots in the ceiling (Figures 123 and 124). **The general condition of FF Office 5 is poor.**

Figure 121: IR image showing bottom of partition wall for FF WC

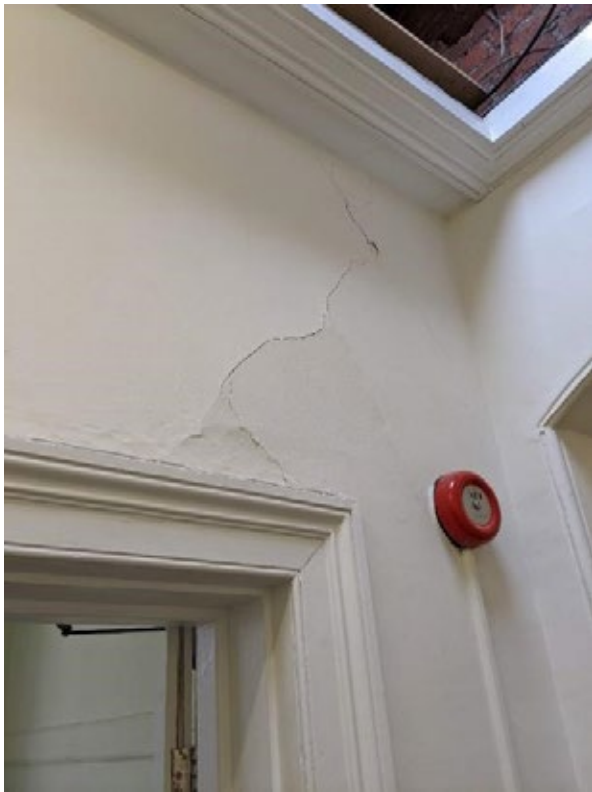
The first-floor corridor provides access to all five offices (Figures 125 and 126). There is a **diagonal crack above the door to Office 5 and vertical crack between the cross wall and internal partition wall** (Figures 127 and 128). Access to the roof space is via a hatch located in the corridor (Figures 129 and 130). From floor level, there appears to be mineral wool insulation in the roof space. There is a roof window, which provides access to the flat roof area. This was not accessed by the ABC team. **The general condition of the corridor appears to be satisfactory to poor.**

Figure 127: Diagonal crack above door to Office 5

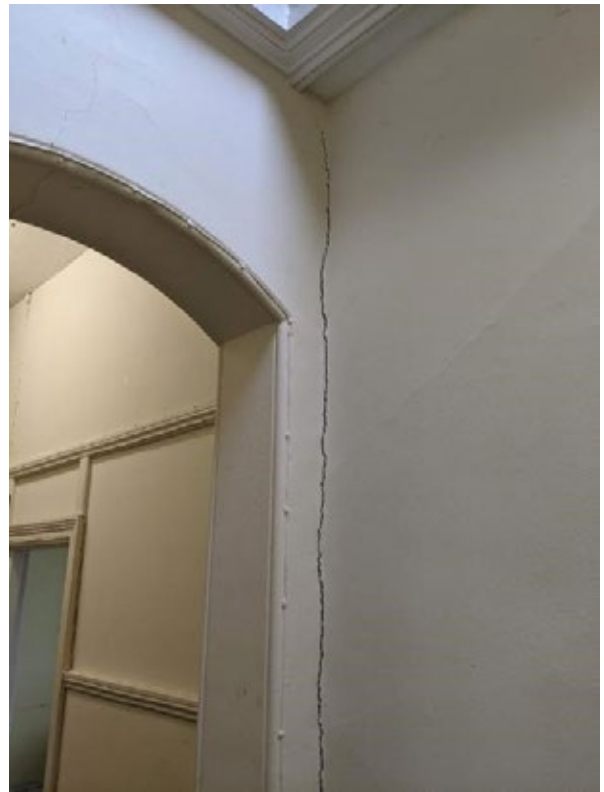
Figure 128: Vertical crack between cross wall and partition wall

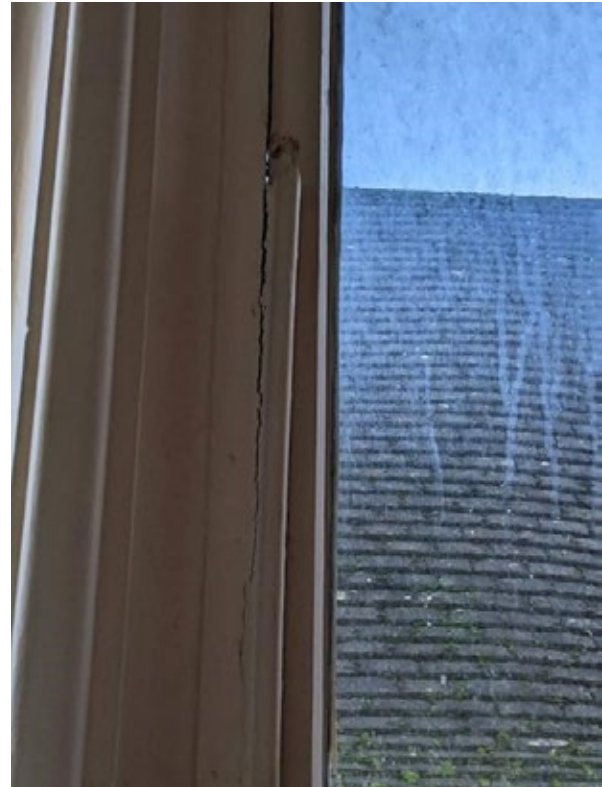
The window in the first floor WC is single glazed with timber mullions and frames (Figures 131). **There is a crack in the frame, large enough for light to get through** (Figure 132).

Figure 132: Crack in FF WC window frame

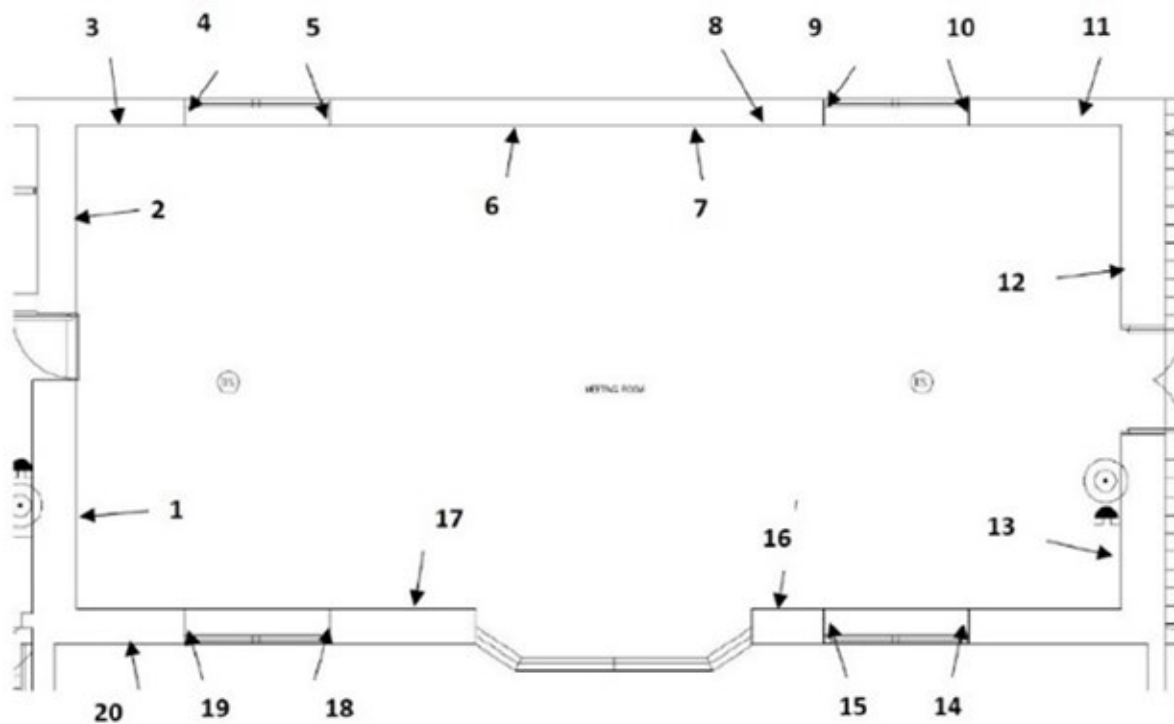
Table 11: Moisture readings for Meeting Room (Hall)

The moisture readings were recorded according to the locations set out in Table 12 below. The readings indicate very high moisture levels, indicating there is water ingress in large areas of the building fabric. This is consistent with the staining and the vegetation growth identified in external areas, set out above.

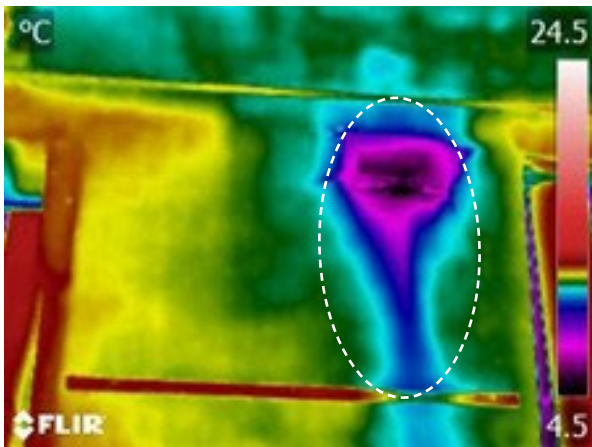
Figure 147: IR image showing air leakage through hole in the main façade wall (west facing)

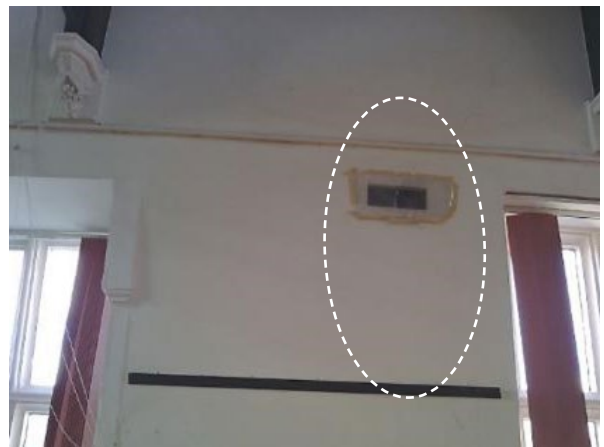
Figure 148: Photograph showing hole in the main façade wall (west facing)

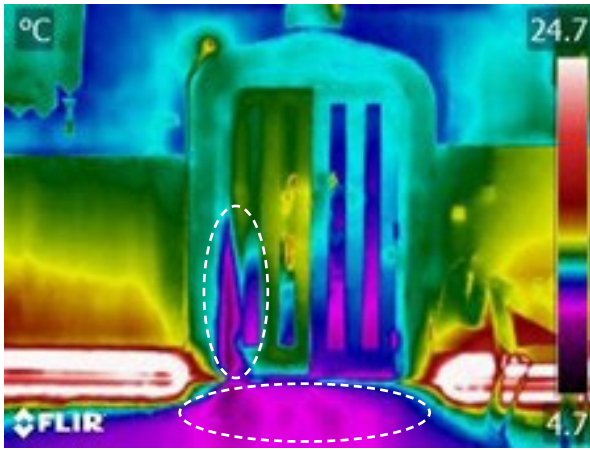
Figure 149: IR image showing air leakage through door into kitchen area and cold meeting room floor

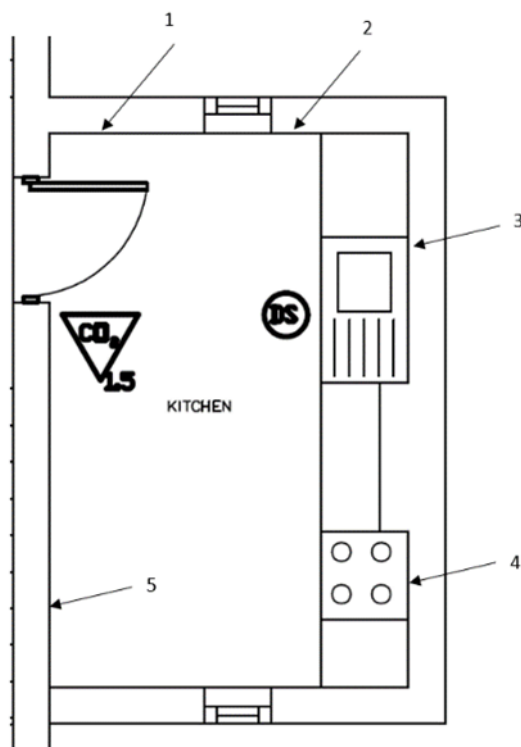
Table 12: Moisture readings for Kitchen

Location Tag	1	2	3	4	5
Moisture Reading	45.7%	100%	100%	54%	68.5%

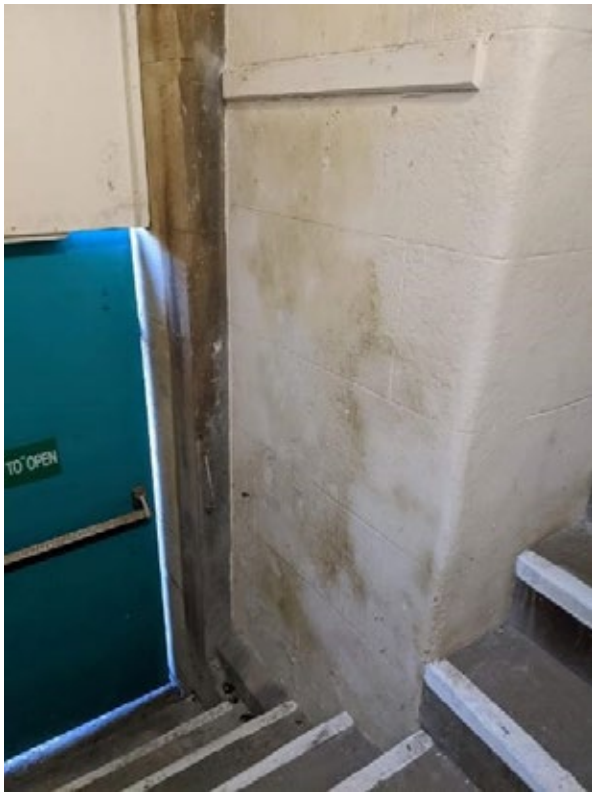
The timber door sits in a stone frame. The stairs are made of concrete. The walls and ceiling appear to have been covered in impervious gypsum and paint. **There is significant staining on the walls and ceiling, with cracks in the plaster and paint** (Figures 157 to 160). The paint has also started to peel off the ceiling (Figure 160).

Figure 157: Staining on lower part of wall for internal emergency stairs

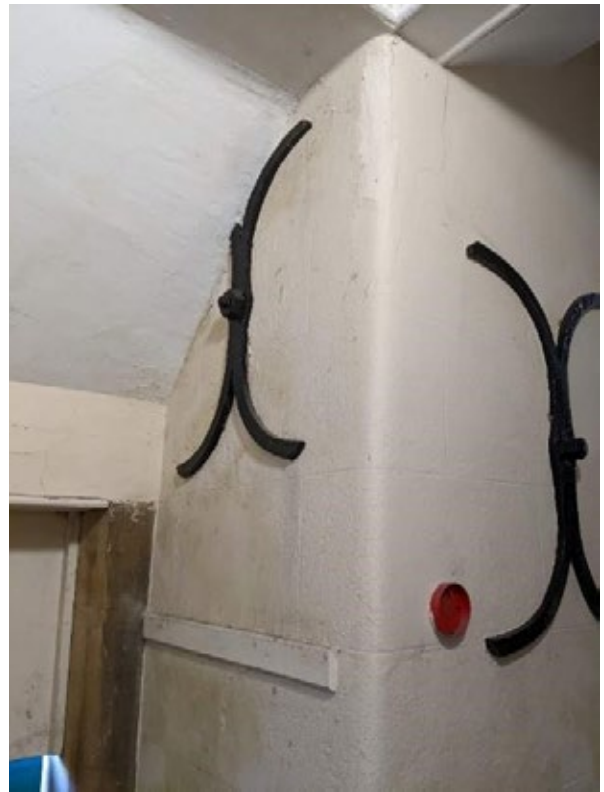
Figure 158: Staining on upper part of wall for internal emergency stairs

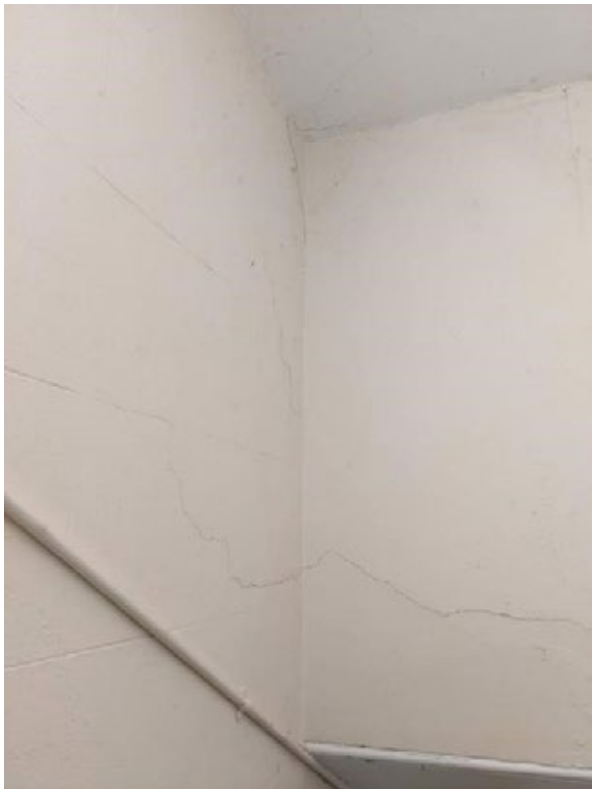
Figure 159: Cracks in paint and plaster on walls of internal emergency stairs

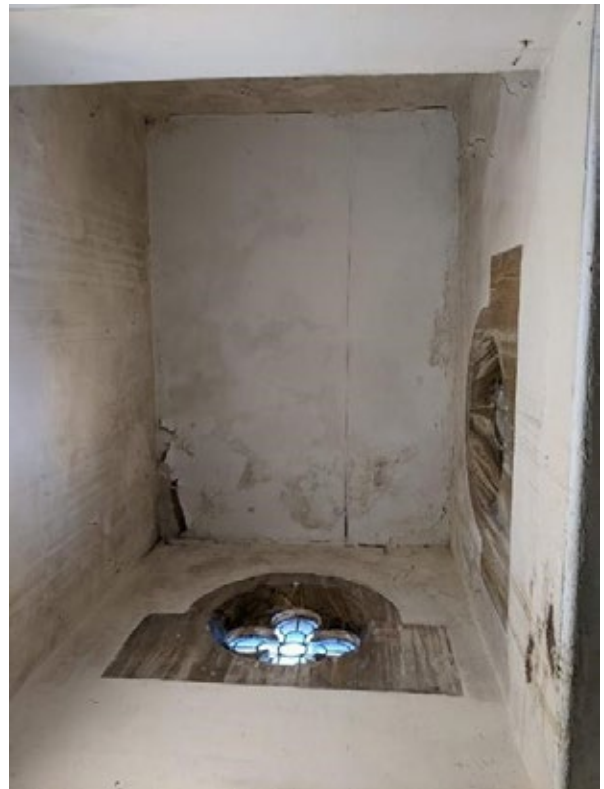
Figure 160: Significant staining to ceiling and upper walls above internal emergency stairs
