Active
Building
Centre

Stroud District Council

Zero Carbon Public Estate programme

Building Performance Evaluation Report

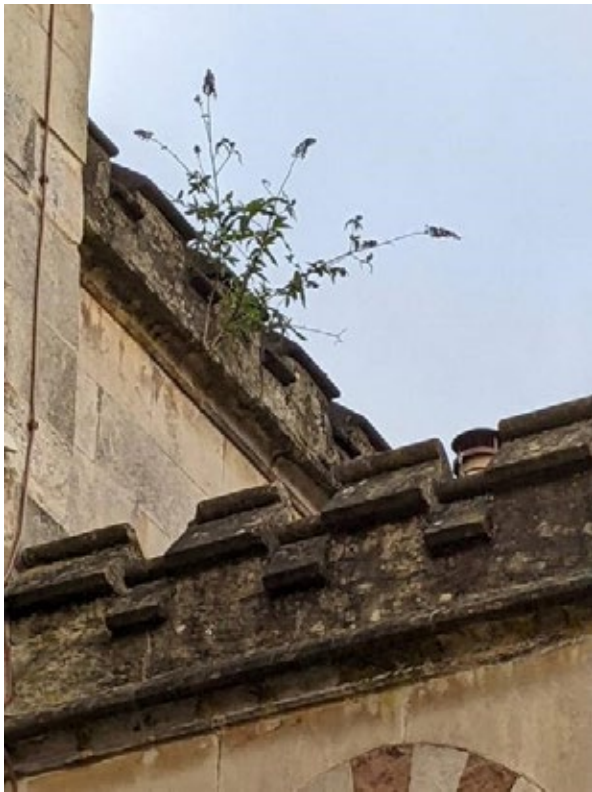
Figure 14 illustrates the crack that runs from the parapet down to entrance door for the ground floor office on the front facade. There is extensive water staining on the stonework on the front of the building, evident in Figures 17 to 19 and Figure 21. Figures 20 through to 23 and 27 show vegetation growth, which appears to be in the stonework and the gutter in Figure 21.

Figure 20: Vegetation growth in stonework of parapet, visible from front of the building

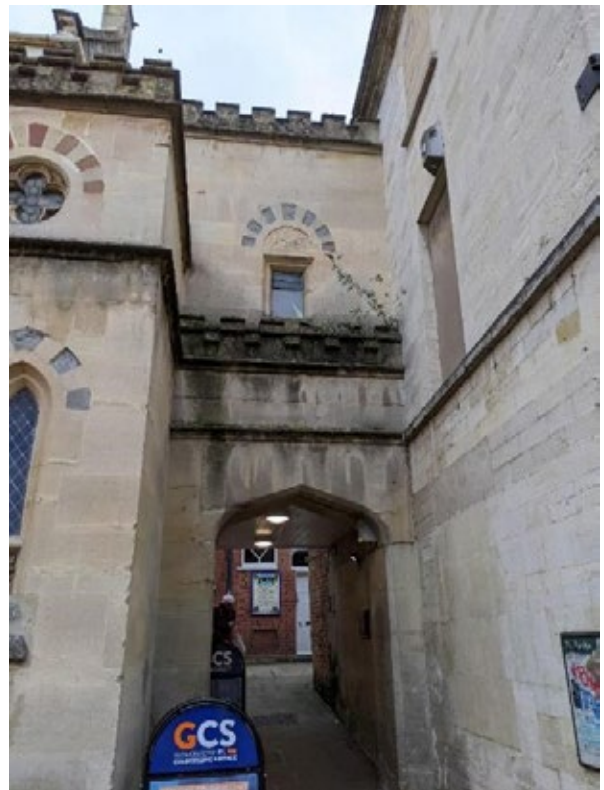
Figures 22 and 23 illustrate some blistering and delamination of the stonework, and mortar joint decay. This could indicate that the embedded iron cramps are corroded and therefore expanding. Additionally, there appears to be some salt crystallisation.

Figure 23: Archway and walkway under first floor kitchen, with vegetation growth in stone corncicing

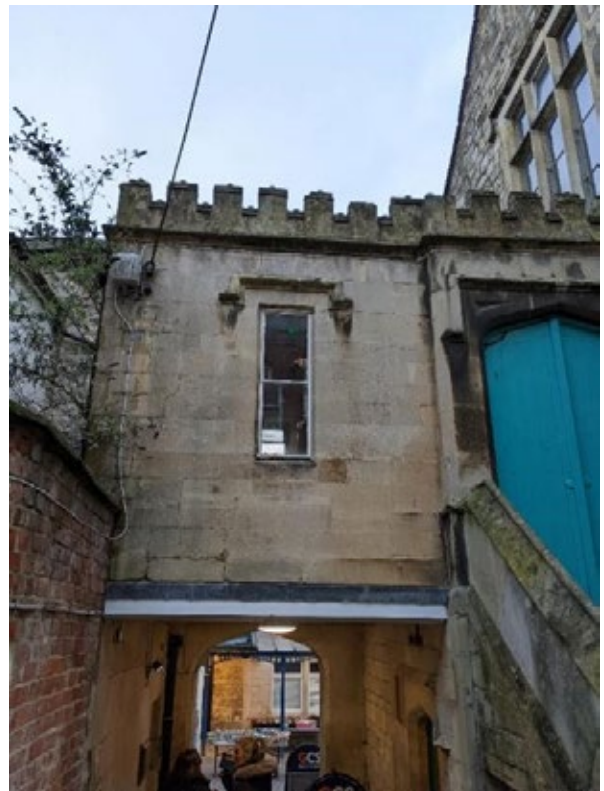
Figure 27: Rear wall of first floor kitchen above walkway

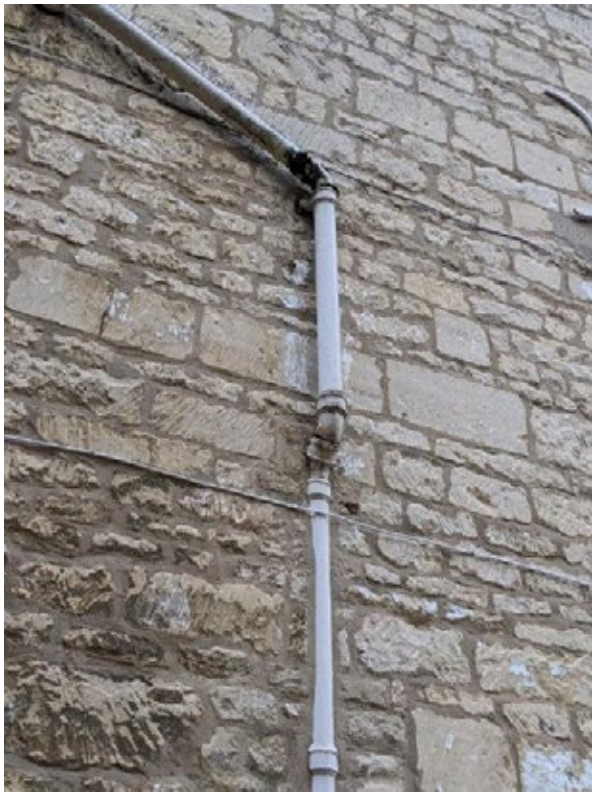
Figure 32: Rainwater pipe sunk into rear wall

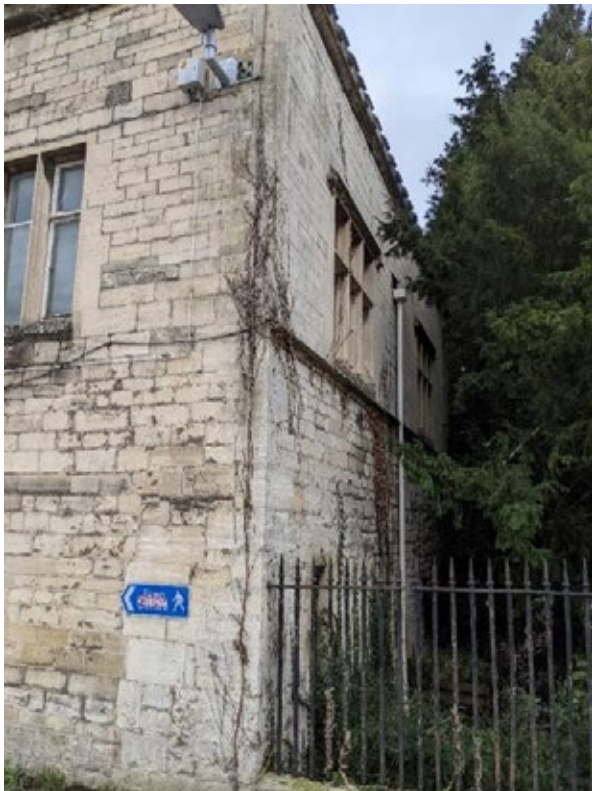
Figures 28 and 29 illustrate pointing in the stonework that appears to be cement based. Figure 33 illustrates water staining on the rear wall. Figures 34 and 35 illustrate further vegetation growth on the north wall, facing the Church. **The general condition of the external areas is satisfactory to poor, with areas that are very poor.**

Figure 34: North wall, facing Church

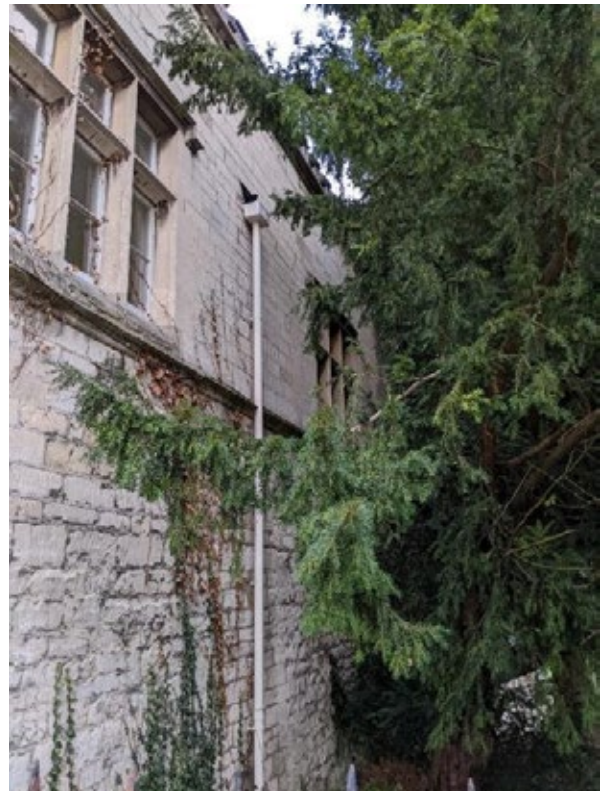
Figure 35: North wall, with extensive vegetation growth

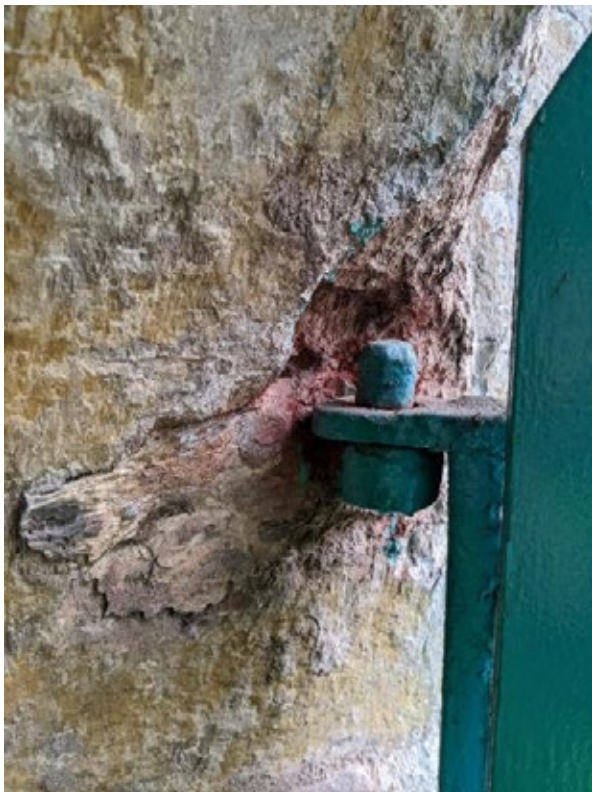
The stone frame entrance to the store has cracking, erosion and delamination visible, as shown in Figures 40 and 41. The timber holding the door hinge appears to be decaying, as shown in Figure 42.

Figure 42: Store 2 entrance door hinge

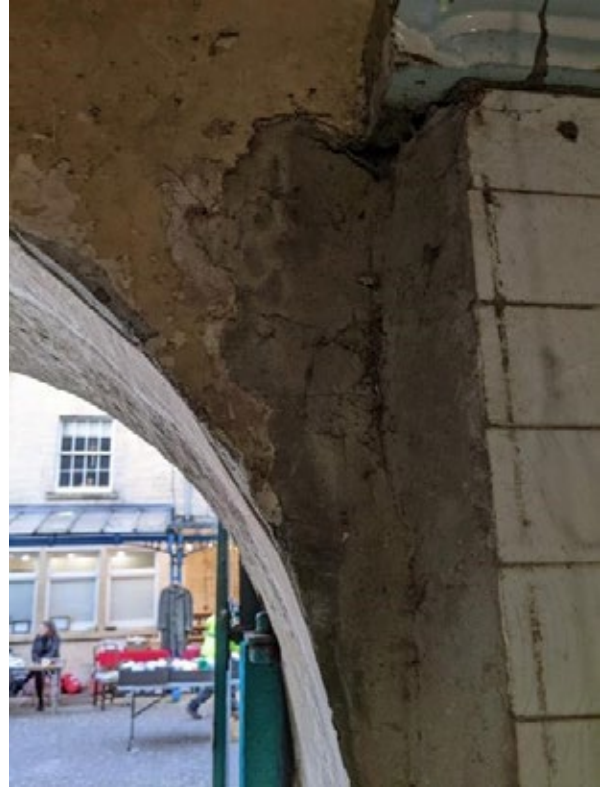
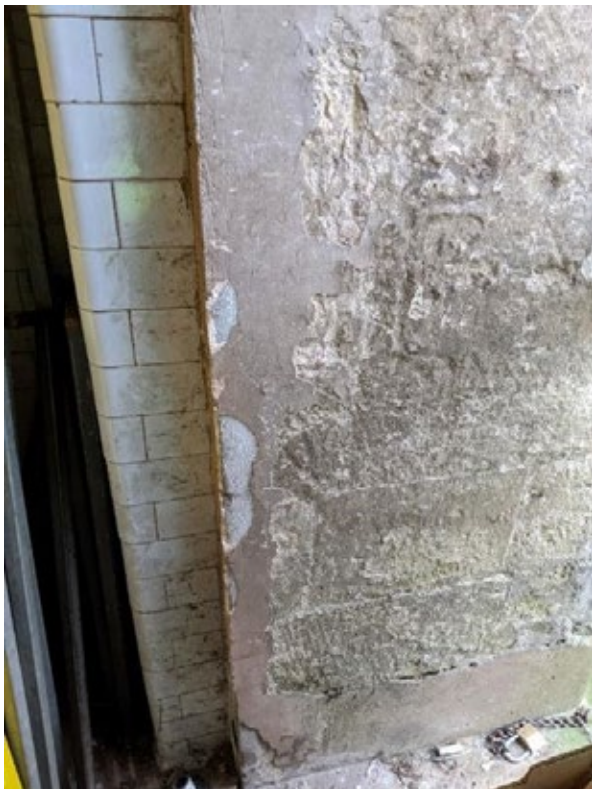
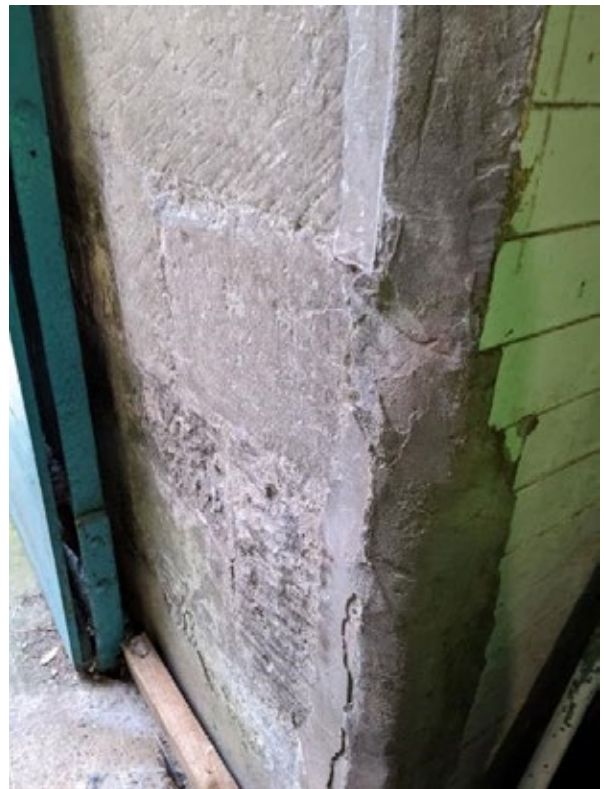
Figures 43 to 46 show the entrance to store 3. The photographs illustrate the apparent use of cement from previous repairs to the stone frame entrance.

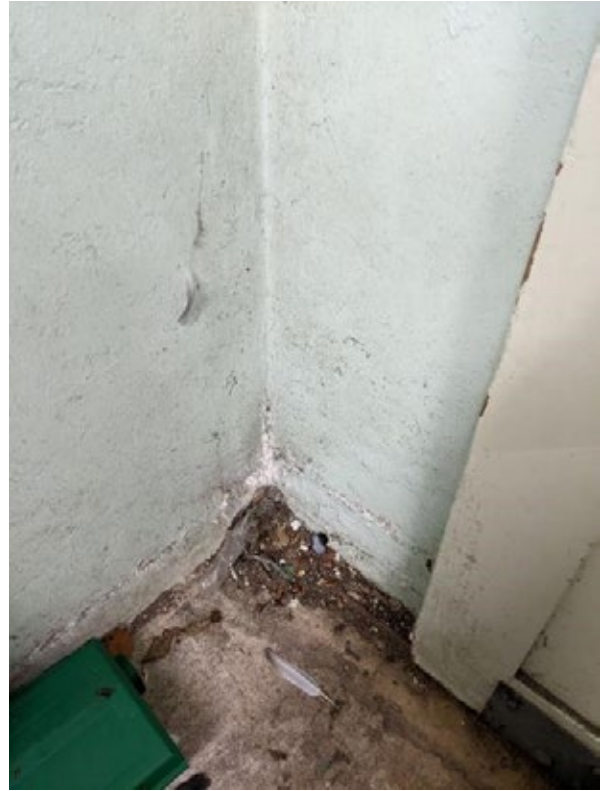
There are several services in this store, including hot and cold water, waste pipes and electricity, most of which can be seen in Figure 47. Three of the walls in this store appear to have been covered with gypsum plaster and all four have been painted with an impervious paint. Figures 48 to 50 illustrate evidence of salt crystallisation, blistering and delamination within the plaster, which is consistent with moisture penetration. Figures 51 and 52 show the timber beam, which appears to have been subjected to severe decay.

Figure 48: Salt crystals on surface of wall in corner

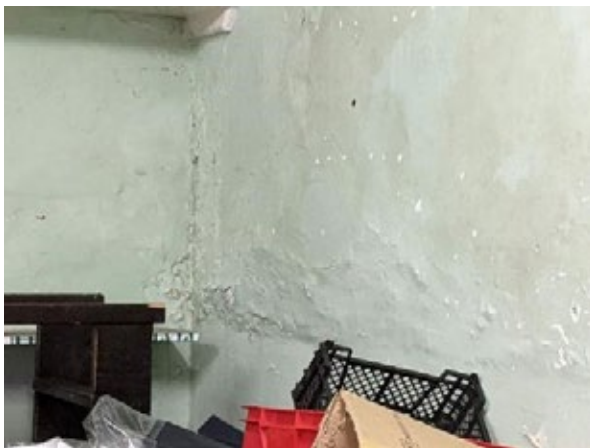
Figure 49: Blistering of plaster behind the paint

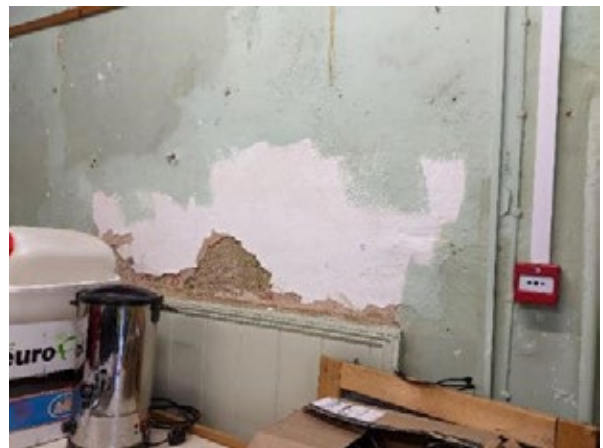
Figure 50: Delamination of the gypsum plaster

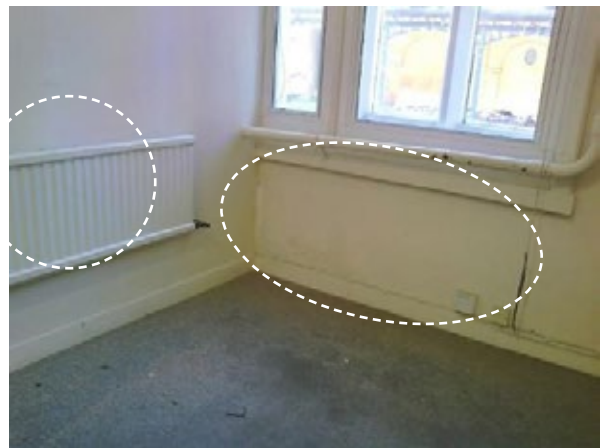
The radiator appears to have been turned down due to the room being unoccupied (see Figures 55 and 56). However, the large bore central heating pipe travels through the room to provide space heating to Office 2 and 3 on the other side of the wall. **The heat being emitted from this un-lagged pipe appears to be significant** (Figures 55 and 57). Despite this apparent heat gain, the internal temperature is low at below 15°C. This is likely to be due to the heat loss through the window, in particular the louvre (Figure 53), the wall below the window (Figures 55 and 56), and the vent in the top right corner (Figures 57 and 58). **The general condition of GF Office 1 is poor.**

Figure 56: Photograph showing wall under window in GF Office 1

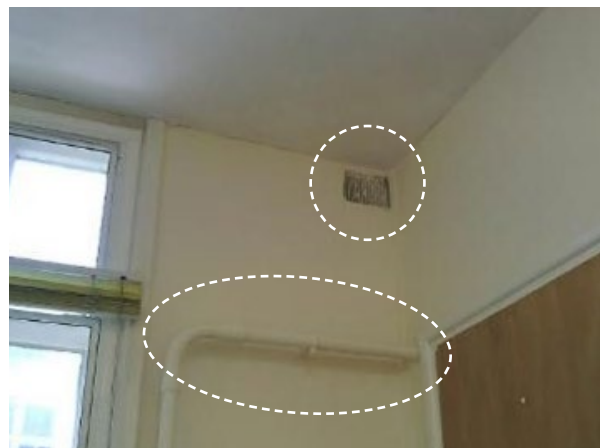
Figure 57: IR image showing vent and hot water pipe in GF Office 1

Figure 58: Photograph showing vent and hot water pipe in GF Office 1

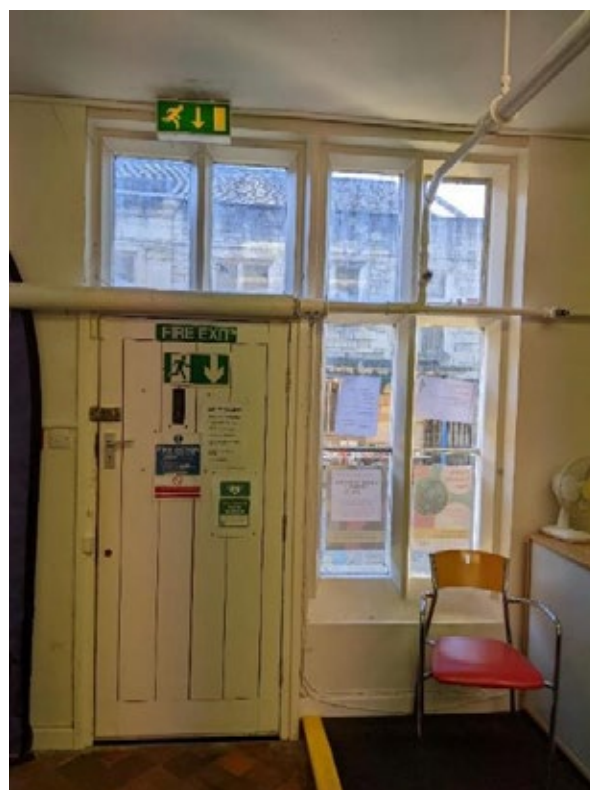
The heating system pipes are a dominant feature in Office 2 as it is suspended from the ceiling and travels from Office 1 and into Office 3 above the entrance door (Figures 59 and 60). The pipe continues to be suspended from the ceiling in GF Office 3 and into the storage area behind, which is accessed via Office 2 (Figures 61 and 62). The ceiling in Office 2 and storage area behind is brick and vaulted. The entrance door from outside and window, and their frames are timber (Figure 60). The window mullions in Office 3 are stone, with a steel casement holding the glass (Figures 63 and 64). Both windows are single glazed. There is an old steel shutter on the internal side of the window in Office 3. **This window is in a poor condition.**

Figure 59: GF Office 2

Figure 60: Entrance door at front of building in GF Office 2

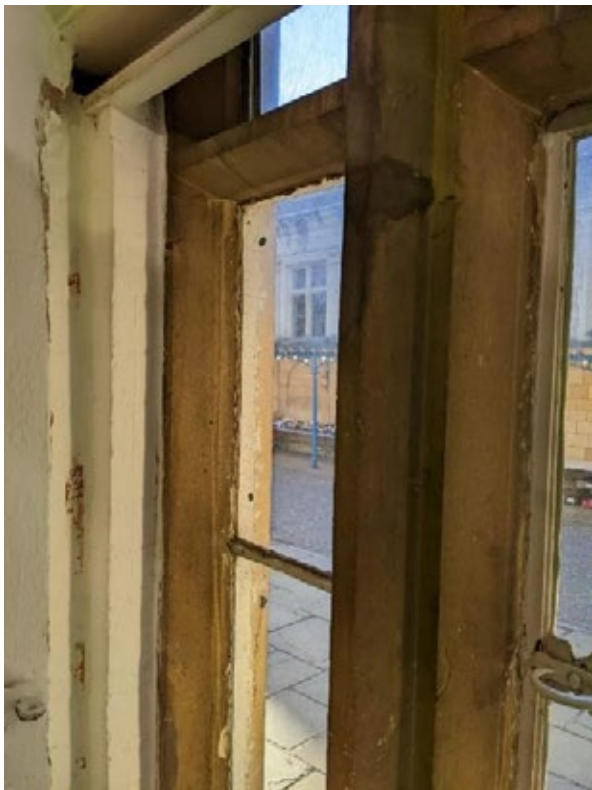
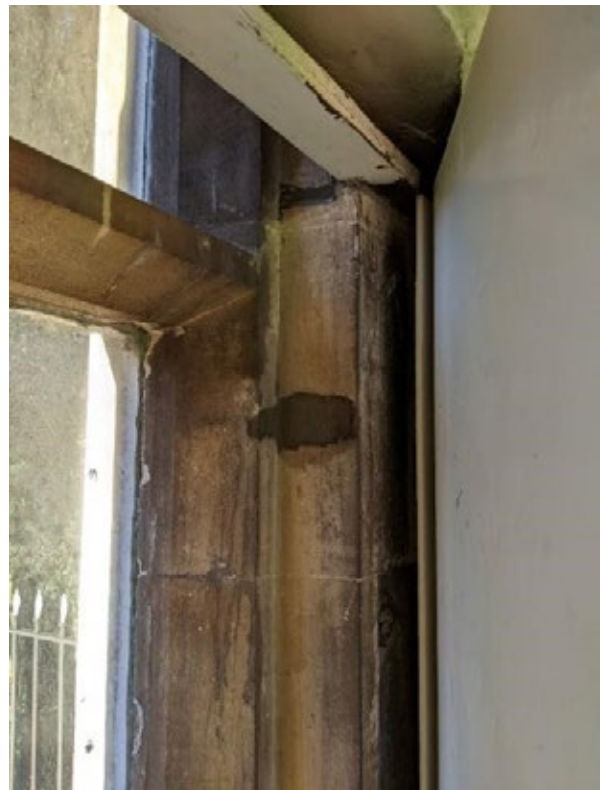
Figure 63: Window frame in GF Office 3

Figure 64: Window frame in GF Office 3

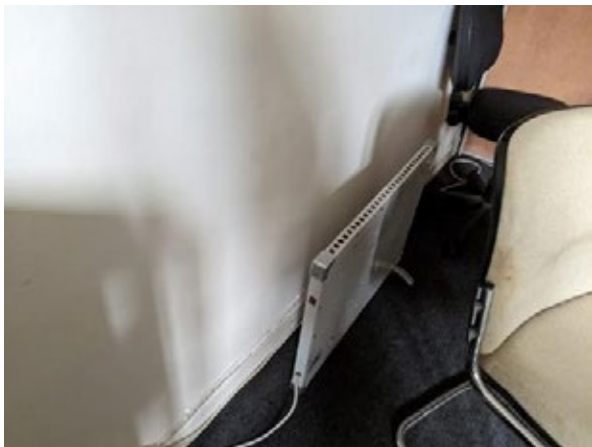
Both offices had additional free-standing portable electric heaters, which is consistent with the information provided in the preliminary BPE and occupant survey (Figures 67 and 68). These heaters were not in use at the time of collecting the data. The environmental data was recorded within two to three hours after the offices had been in use. When these offices are in use, they are open to the public. Public access to the offices is via the entrance door at the front of the building, shown in Figure 60. Although the internal temperature is higher than Office 1, this is still low given that this space had been occupied.

Figure 67: Electric heating panel in Office 2

Figure 68: Instantaneous heater in Office 2

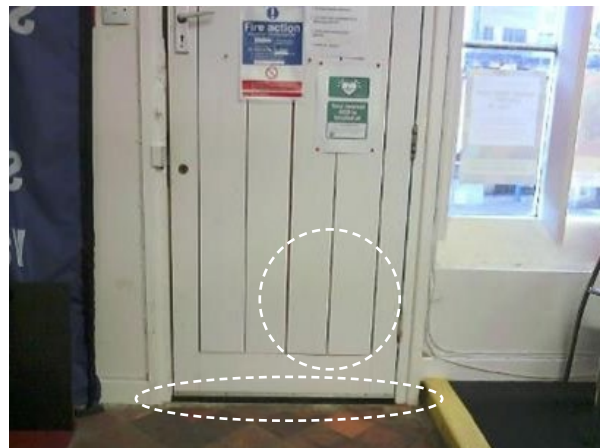
Significant infiltration heat loss was identified in Office 2 and 3. There are gaps below and within the entrance door in Office 2, contributing to this heat loss (Figures 69 and 70). There is also heat loss from the vent at the bottom of the north external wall in Office 2 (Figures 71 and 72). Both are allowing uncontrolled infiltration of cold air into the internal spaces.

Figure 69: IR image showing bottom of entrance door into GF Office 2

Figure 70: Photograph showing bottom of entrance door into GF Office 2

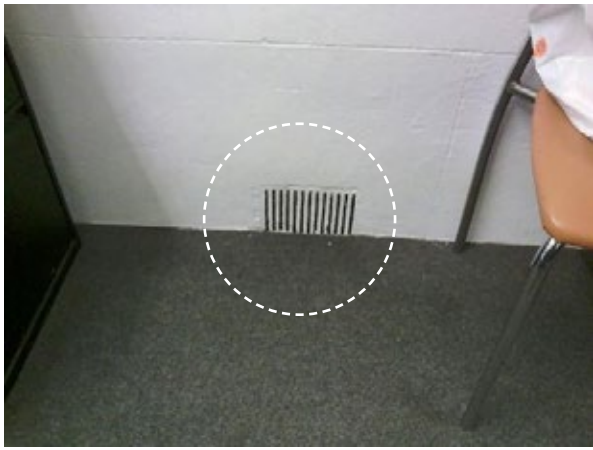
Figure 71: IR image showing vent at bottom of north external wall in GF Office 3

Figure 72: Photograph showing vent at bottom of north external wall in GF Office 3

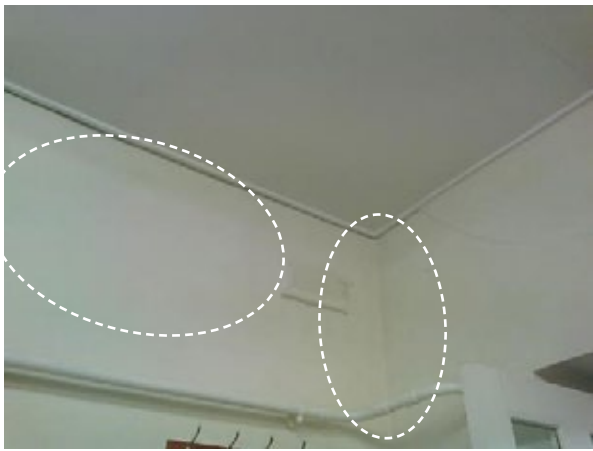
Several occurrences of thermal bridging appear to be present on the walls in these two offices and the storage areas at the rear. There are two areas identified at the top of the front external wall, just before entering Office 3 (Figures 73 and 74). **These require further investigation to identify the cause.** In the kitchenette there is several occurrences of thermal bridging (Figures 75 and 76). These are from: the 'dabs' where the dry lining has been fixed to the existing wall; the external wall to partition wall and ground floor junctions; and the mains gas pipe entry point. The thermal bridging at the external wall junctions is likely to be exacerbated by the dry lining. In the storage area behind Office 3, there appears to be thermal bridging around the window at the rear of the room, and in the rear corner. The latter appears to be at the junction between the dry lining plasterboards. **The general condition of GF Office 2 and 3 is satisfactory to poor, with areas that are very poor.**

Figure 73: IR image showing top of external wall, next to door between Office 2 and 3

Figure 74: Photograph showing top of external wall, next to door between Office 2 and 3

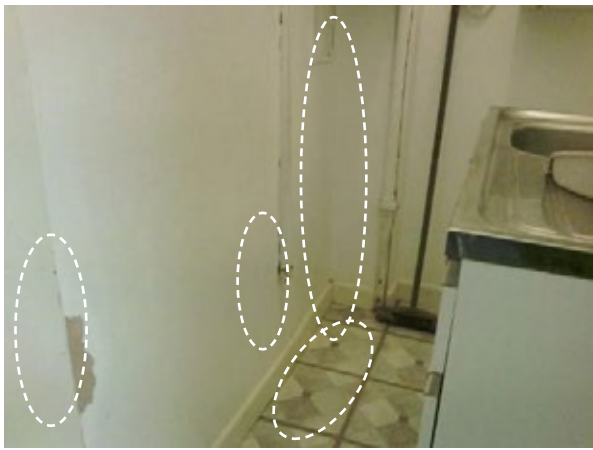
The moisture readings were recorded according to the locations set out in Table 4 below. The readings indicate that there is potential water ingress in the walls. The readings in locations 6 to 11 and 13 could be lower due to the dry lining that is on these walls (see below in reference to Figures 75 and 77). Location 12 could be where the adhesive is bridging between the existing wall and the plasterboard lining. **These high moisture readings require further investigation.**

Figure 75: IR image showing heat loss through wall junction and plaster dabs.

Figure 76: Photograph showing wall and wall junction.

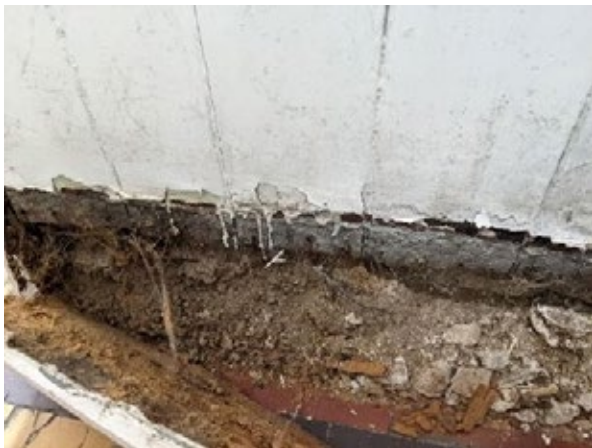
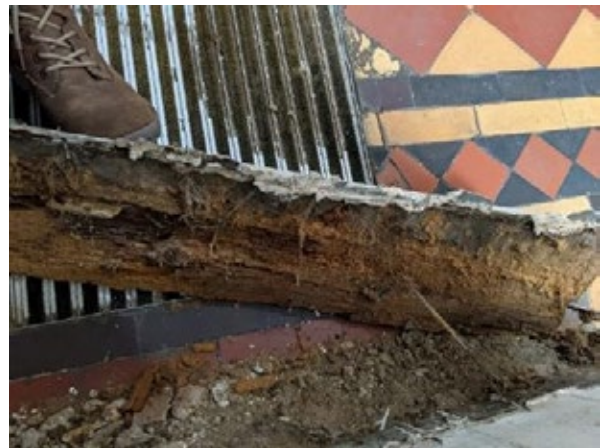
The main entrance door to the building is solid wood in a stone frame. **There are large gaps around the door**, illustrated by the visibility of light when the door is closed. The floor is tiled and there is timber panelling on the wall behind the door. **There is significant decay of the timber skirting** below the timber panelling and behind where it should be fixed to the wall. The decay is consistent with the high moisture readings. **The general condition of the GF entrance lobby is satisfactory to poor, with areas that are very poor.**

Figure 81: Behind loose skirting

Figure 82: Back of loose skirting

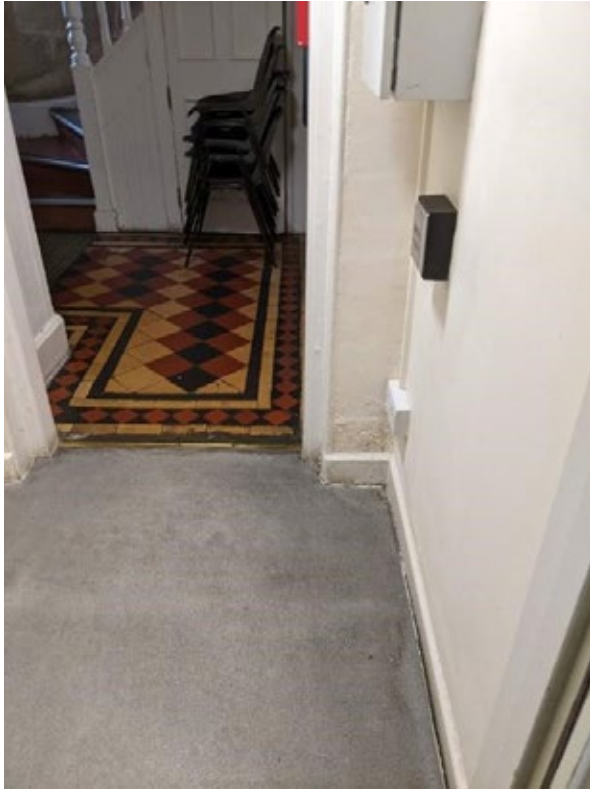
On the ground floor, the entrance lobby leads to a small circulation space where the offices can be accessed. The floor changes to a solid concrete floor covered in an industrial standard lino (Figures 83 and 84). There is blistering and tide marks on the internal walls (Figures 83 to 86). This is consistent with an impervious floor material, such as cement, being retrofitted to the building which would have probably been built with a suspended timber ground floor. As a result, the ground moisture appears to be travelling up the walls by means of capillary action. This is further exacerbated by the addition of an impervious gypsum and painted wall covering. **The general condition of GF circulation space is satisfactory to poor.**

Figure 83: Floor of lobby and access to GF circulation space

Figure 84: Entrance door into GF circulation space

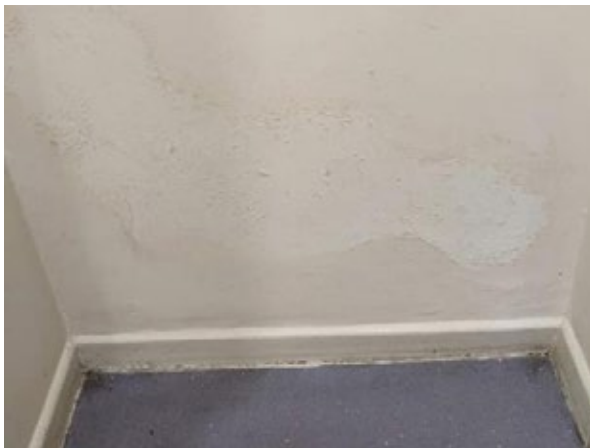
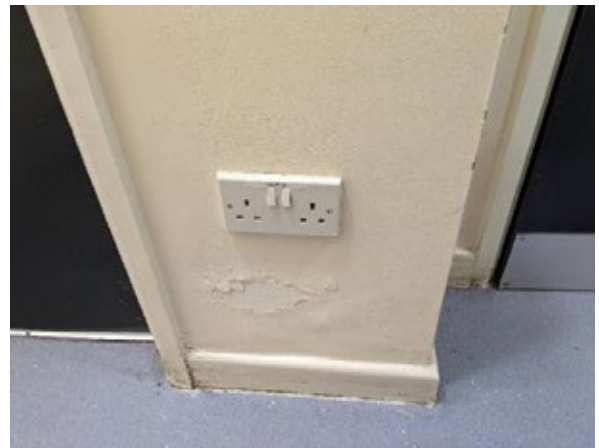
Figure 85: Water ingress into GF interior walls

Figure 86: Water ingress into GF interior walls

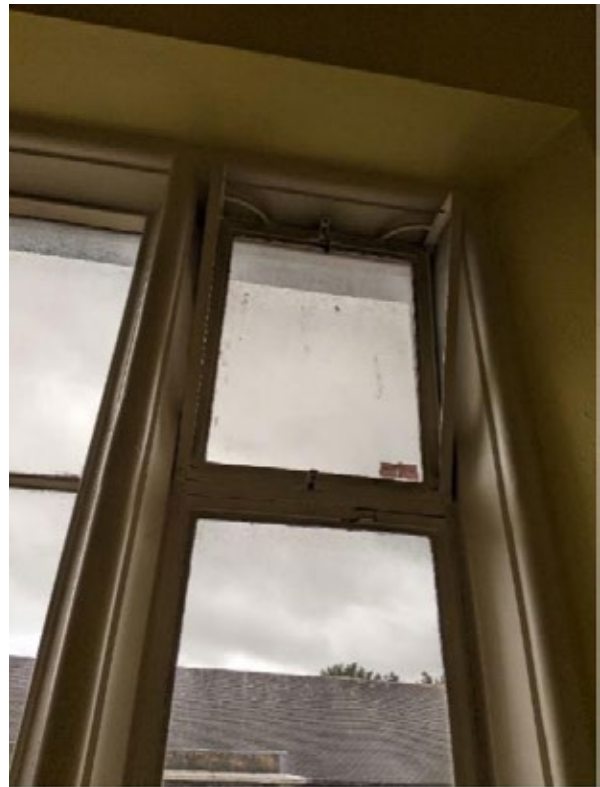
The first floor Office 1 has a large metal and timber framed window and a chimney breast. The walls are papered. The suspended intermediate timber floor has a hardboard covering. The openable section of the window is at the top left and right of the casement (Figures 83 and 84). They are hinged at the bottom and there are support frames restricting the opening gap at the top.

Figure 88: Top right of window, showing hinged openable section

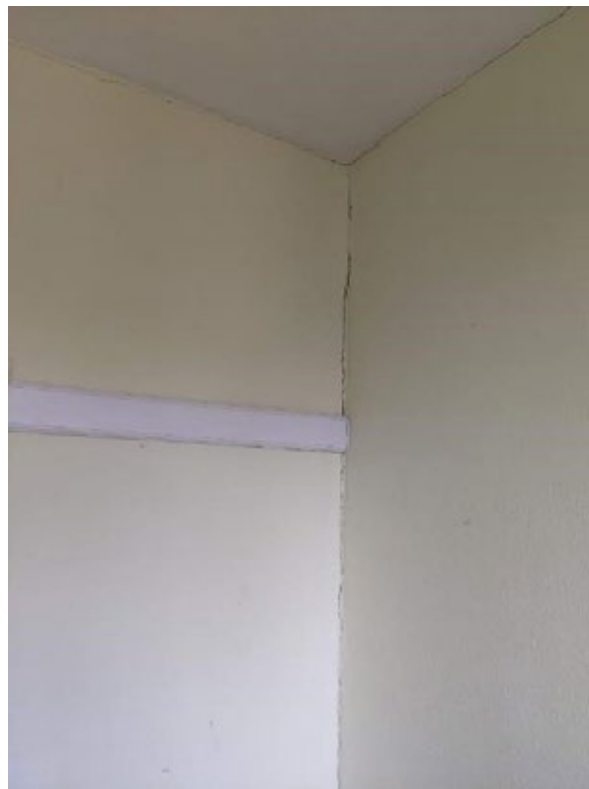
There is vertical crack between the partition wall and chimney breast (Figure 95). There is also a vertical crack in the corner between the partition wall for Office 1 and the corridor (Figure 96). Heat transmission can be seen in the location of the crack (Figures 99 and 100). **The cause of these cracks should be investigated by a Structural Engineer.** There are holes in the partition walls, which has exposed their structure (Figures 97 and 98). The partition walls appear to have been constructed using laths and lime plaster. The walls have since received a layer of gypsum plaster. There appears to be **gaps in the roof insulation**, illustrated by the cold spots in Figures 101 and 102. **The general condition of FF Office 2 is very poor.**

Figure 96: Junction between partition wall to FF Office 1 and corridor

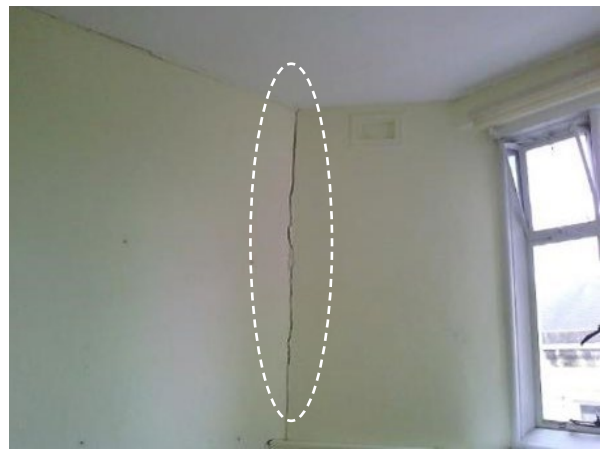
Figure 100: Photograph showing junction between chimney breast and partition wall for FF Office 1

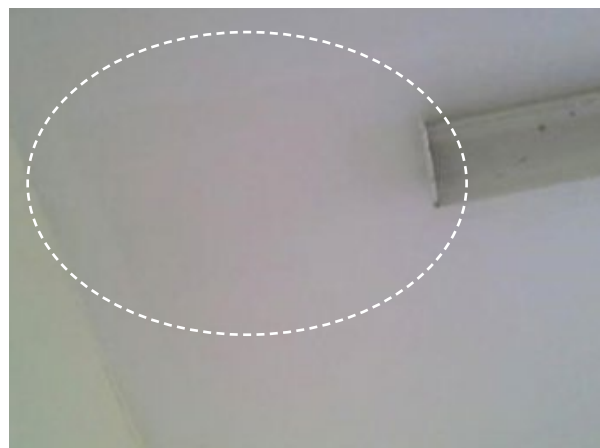
Figure 101: IR image showing cold spots on ceiling

Figure 102: Photograph showing ceiling

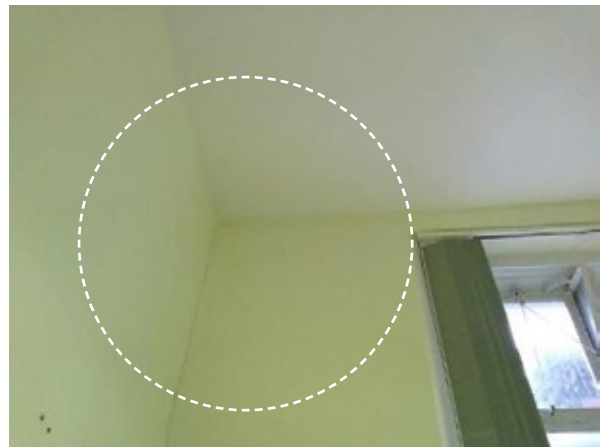
On the external wall at the front of the building, there is a cold area in the corner junction with the roof and the partition wall with Office 2 (Figures 101 and 102). There are several cold spots indicating thermal bridging on the ceiling Figures 103 to 110. **There appears to be gaps in the insulation in the roof, thus requiring further investigation. The general condition of FF Office 3 is satisfactory to poor.**

Figure 102: Photograph showing area at junction between roof, north wall and Office 2 partition wall

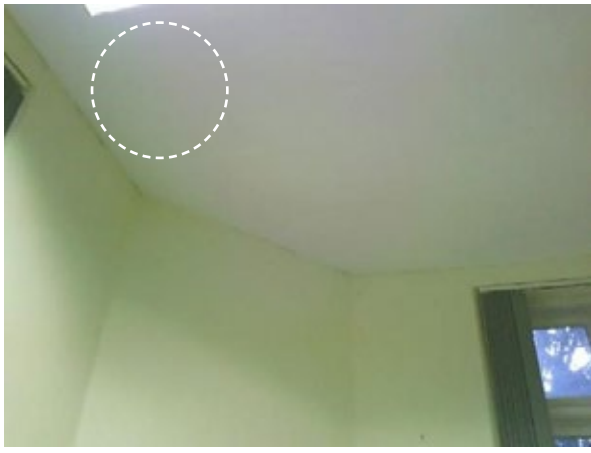
Figure 106: Photograph showing ceiling in FF Office 3

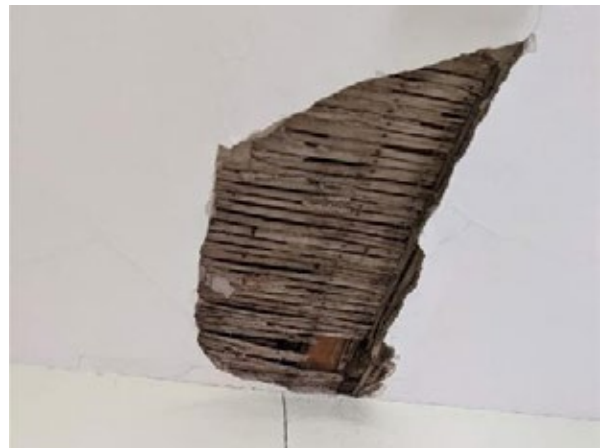
Office 4 on the first floor has two single glazed windows, one facing north on the side of the building and the other on the rear façade (Figures 111 and 112, respectively). The windows have timber mullions with metal frames. There is movement in the floor in the corner closest to the external wall and partition wall with FF Office 5 (Figure 113). **The ceiling has a large area of missing plaster, likely caused by it having got wet and falling away from the laths (Figure 114).**

Figure 114: Ceiling in FF Office 4

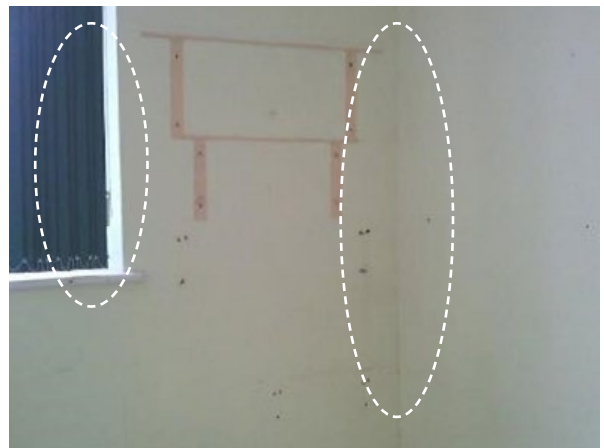
There appears to be thermal bridging at the window reveal and the junction between the external wall and partition wall with FF Office 5 (Figures 115 and 116). There is a further hole in the ceiling causing significant heat loss (Figures 117 and 118). **The general condition of FF Office 4 is very poor.**

Figure 115: IR image showing window reveal and external wall to partition wall junction next to Office 5

Figure 116: Photograph showing window reveal and external wall to partition wall junction next to Office 5

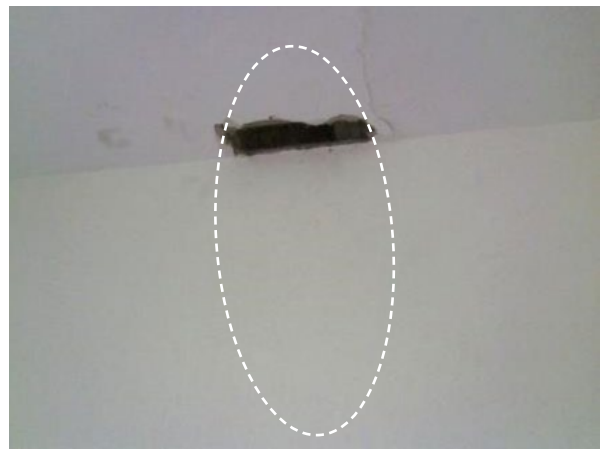
Figure 117: IR image showing hole in ceiling in FF Office 4

Figure 118: Photograph showing hole in ceiling in FF Office 4

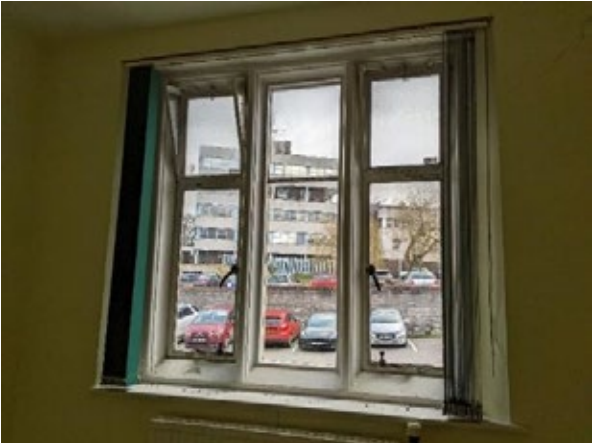
Office 5 on the first floor has one single glazed window facing east at the rear of the building (Figure 119). It has timber mullions with metal frames. There is a **diagonal crack** from the window reveal (near the top) and the ceiling (Figure 120).

Figure 119: Window in FF Office 5

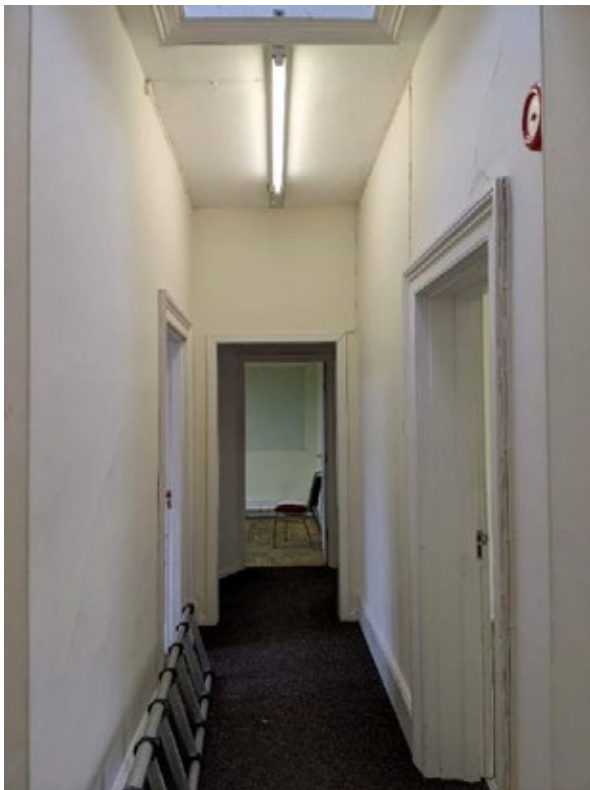
The first-floor corridor provides access to all five offices (Figures 125 and 126). There is a **diagonal crack above the door to Office 5 and vertical crack between the cross wall and internal partition wall** (Figures 127 and 128). Access to the roof space is via a hatch located in the corridor (Figures 129 and 130). From floor level, there appears to be mineral wool insulation in the roof space. There is a roof window, which provides access to the flat roof area. This was not accessed by the ABC team. **The general condition of the corridor appears to be satisfactory to poor.**

Figure 125: FF corridor providing access to all five offices

Figure 126: FF corridor providing access to all five offices

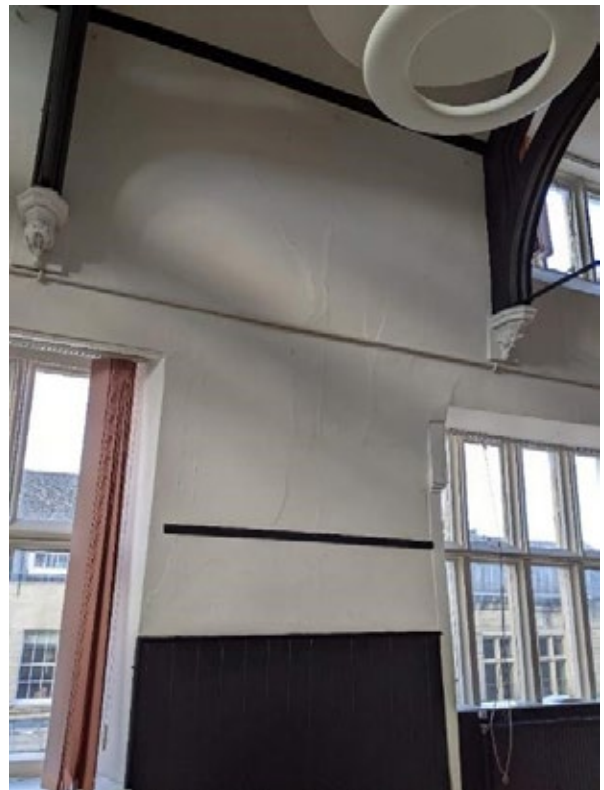
Figure 136: Internal surface of front (west) facing external wall - main facade

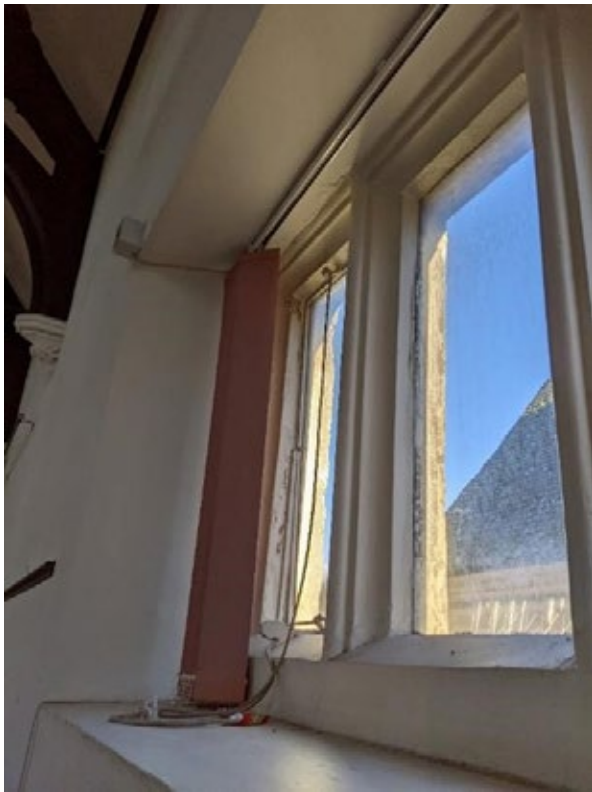
Figure 137: Window in the rear (east) facing wall

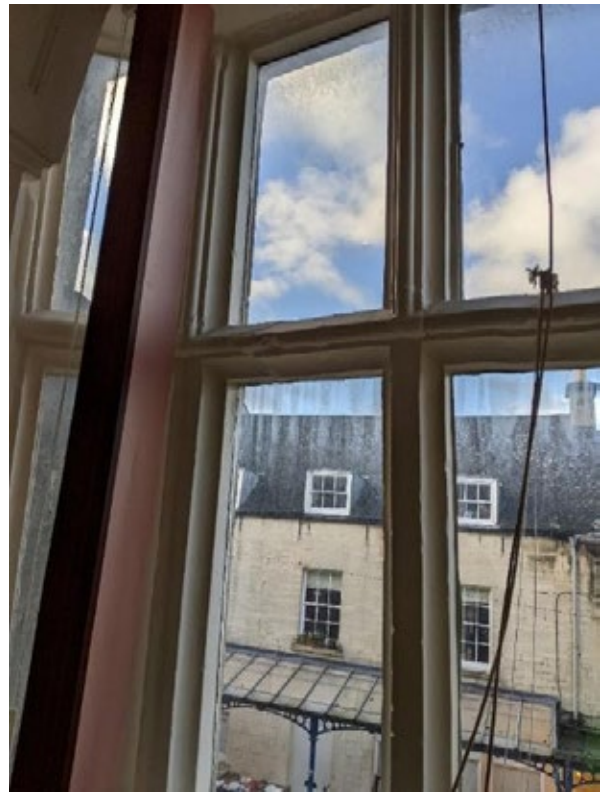
Figure 138: Window in front (west) facing wall

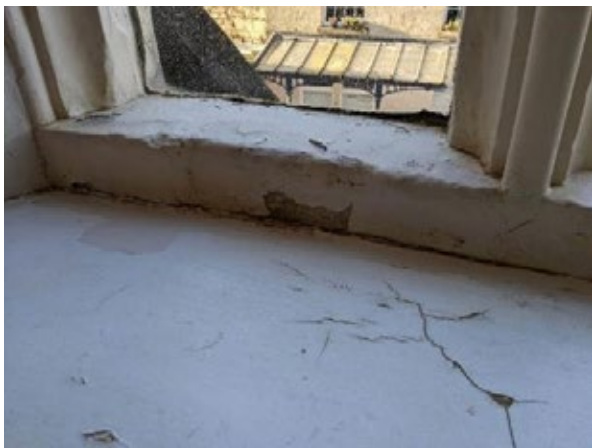
Figure 139: Painted stone window mullion and sill

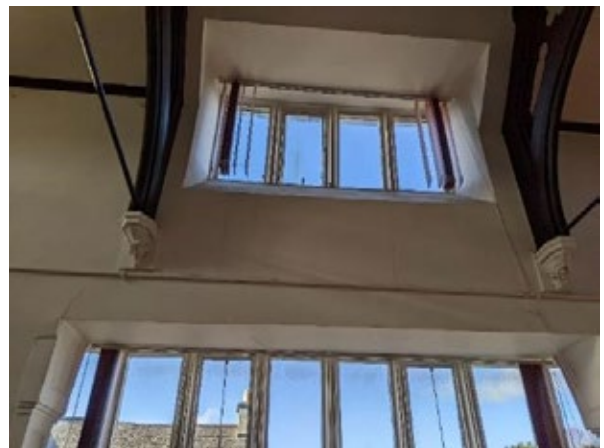
The meeting room (hall) is the main internal space of the original 16th Century building. It is a large space with a very high ceiling and visible ornate trusses. Although not completely visible, the roof structure appears to be a crown post roof truss with metal tie bar system (Figures 133 and 134). There is a large window in the south gable wall (Figure 135) and a smaller window in the north gable wall. The front façade has four large windows, and the rear has three slightly smaller ones. The windows are single glazed in stone mullions and metal frames. The mullions and frames appear to have been painted in a **glossy paint, that has now failed** (Figures 137 to 139). There are **water runs from the bottom of the top window**, above the main front window in the centre of the wall (Figure 140).

Figure 140: Water run marks from bottom of small window above main window of front (west) facing wall

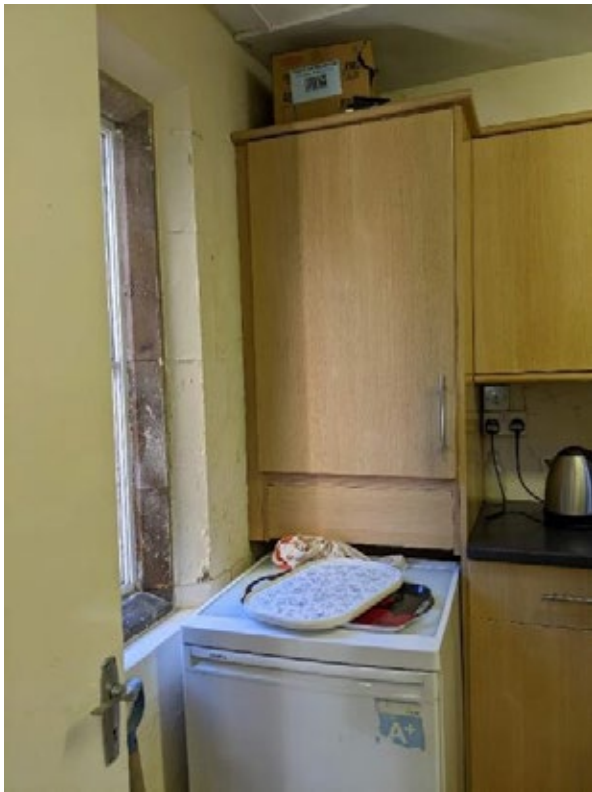
The kitchen is located above the external walkway and is accessed via an unheated space next to the meeting room. Opposite the entrance is a party wall, joining the building on the south of the Old Town Hall. The kitchen has a range of cupboards, a fridge, cooker with hood and sink (Figures 151 and 152).

Figure 151: Fridge, cupboards, and rear window in kitchen

Figure 152: Small kitchen in the front (west) facing wall

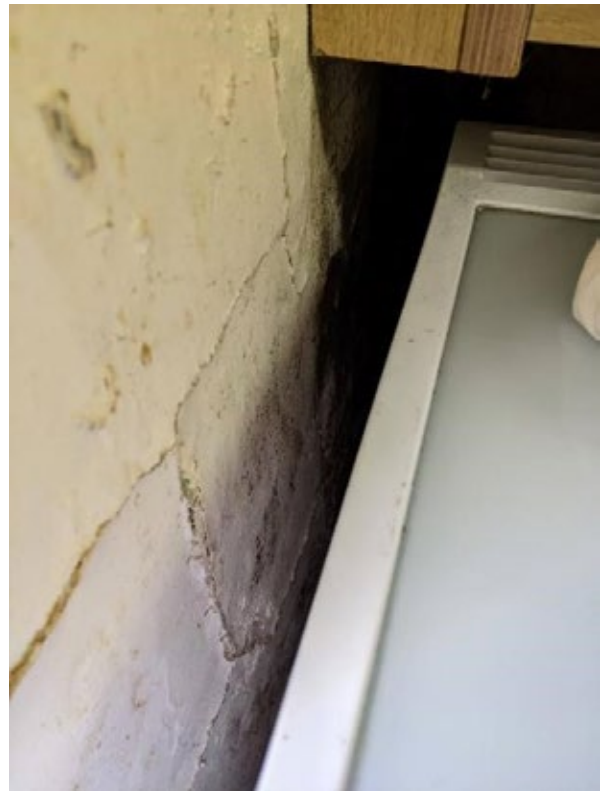
There are **significant signs of water ingress, evidenced by the blistering and salt crystallisation on the surface of the walls.** This is particularly significant on the southern side of the rear window and behind the fridge (Figures 153 and 154). The walls appear to have been covered with impervious gypsum plaster and paint. These areas are consistent with the evidence of moisture with the growth of vegetation in the external areas. **The general condition of the meeting room appears to be very poor.**

Figure 154: Wall behind fridge in kitchen

9. Remove impervious materials that have been added to, or used to replace, original building fabric (roof, walls, windows, and floors) which prevents absorption and evaporation of moisture; these include concrete, cement render, gypsum plaster and plastic or oil-based paints, such as gloss and emulsion
10. Replace with limecrete, lime plaster, limewash and clay paint
11. Repair holes in walls and ceilings when reinstating lime plaster
12. Repair broken window frames and doors
13. Replace broken glass
14. Any inoperable windows should be reinstated as openable to allow for natural ventilation
15. Add draught proofing to windows and doors to reduce uncontrolled air infiltration

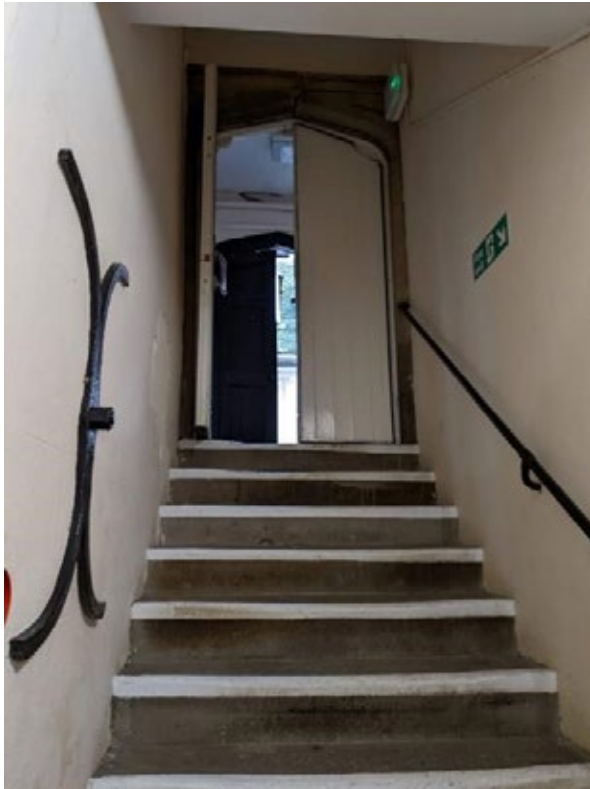
Figure 155: Internal emergency stairs

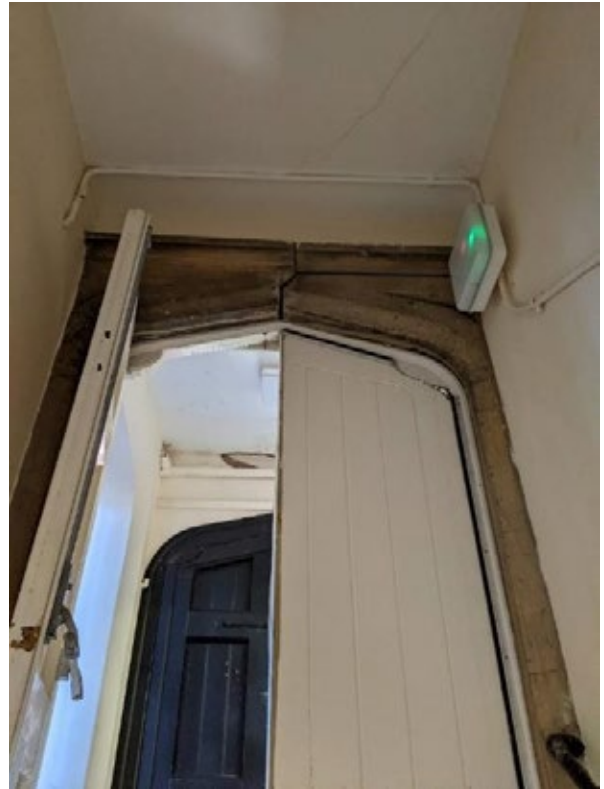
Figure 156: Access door to emergency stairs from unheated space
