Active
Building
Centre

Stroud District Council

Zero Carbon Public Estate programme

Building Performance Evaluation Report

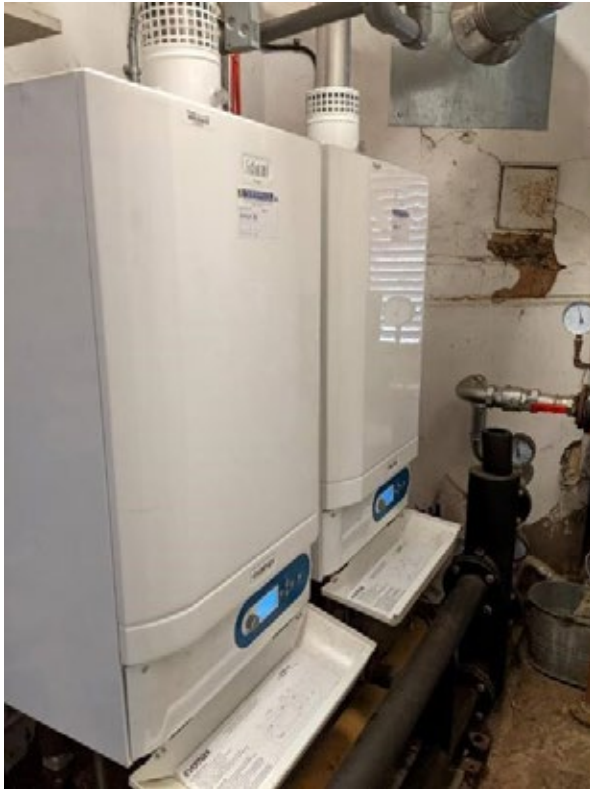
The main heating system is mains gas supplying two combination boilers (Figures 161 to 164). These supply a single pipe system of cast iron radiators throughout the building. The pipes are predominantly uninsulated.

Figure 161: Mains gas boilers in plant room

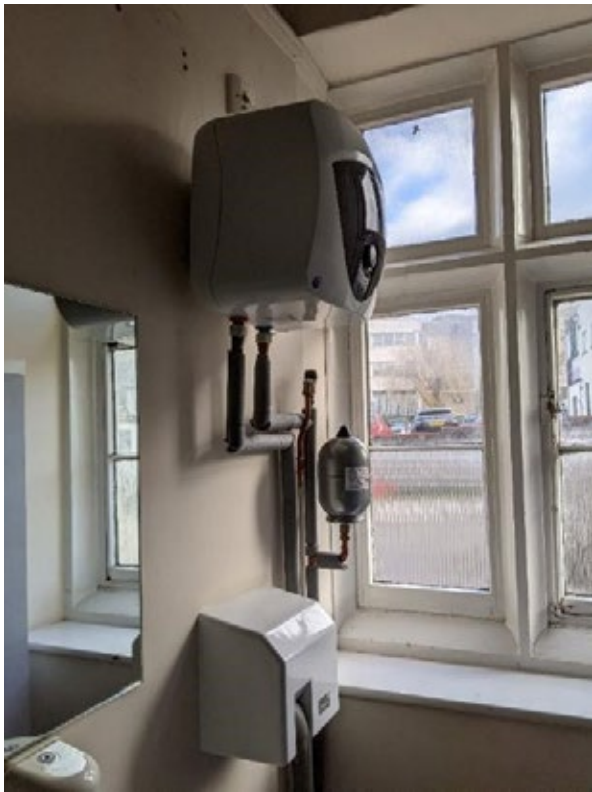
Domestic hot water is provided via electric instantaneous point of use hot water units, located in each of the WCs, kitchenette, and kitchen (Figures 165 to 168). The DHW pipes are predominantly lagged with insulation.

Figure 165: Electric instantaneous hot water unit

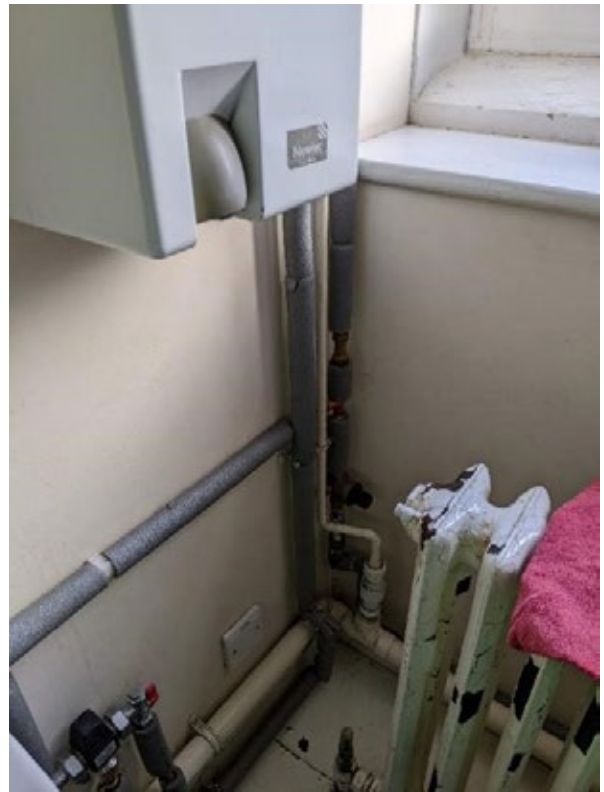
Figure 166: Insulated hot water pipes

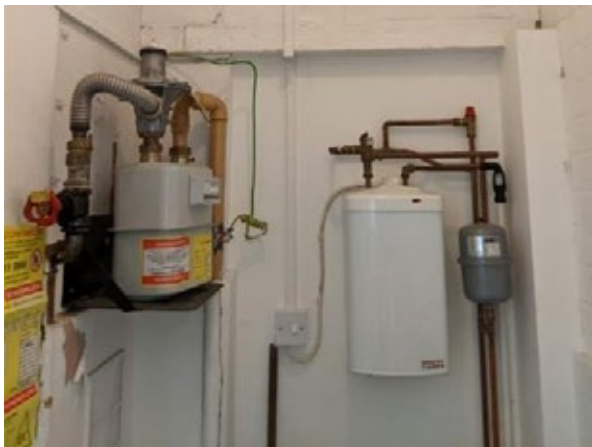
Figure 167: Mains gas meter and electric instantaneous hot water unit

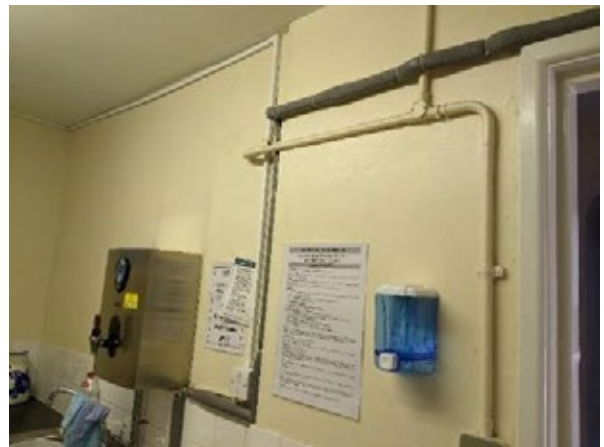
Figure 168: Electric instantaneous hot water unit and insulated hot water pipes
