Active
Building
Centre

Stroud District Council

Zero Carbon Public Estate programme

Building Performance Evaluation Report

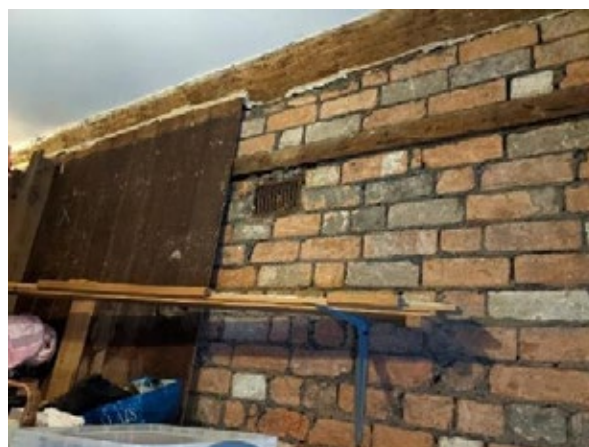
Figure 39: Partition wall

As for Store 1, it was also difficult to see surfaces in Store 2 due to the quantity of items being stored. Figure 38 is the other side of the wall shown in Figure 36 above. Figure 39 is the other partition wall. It is a solid wall with a mix of Flemish and common brick bond. The mortar joints appear to be in relatively poor condition.

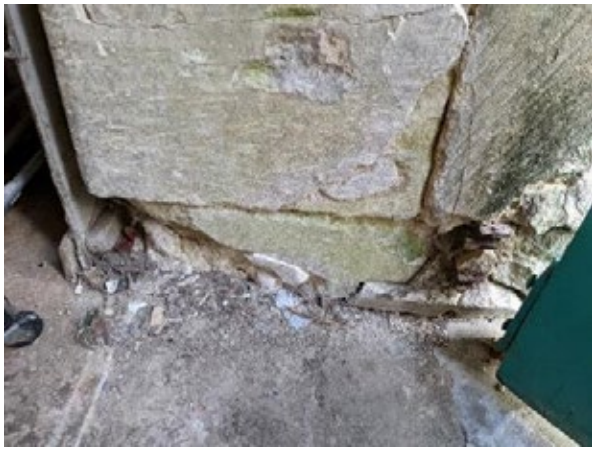
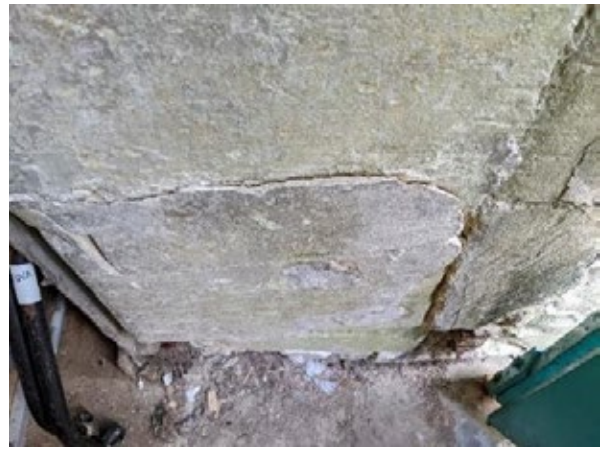
The stone frame entrance to the store has cracking, erosion and delamination visible, as shown in Figures 40 and 41. The timber holding the door hinge appears to be decaying, as shown in Figure 42.

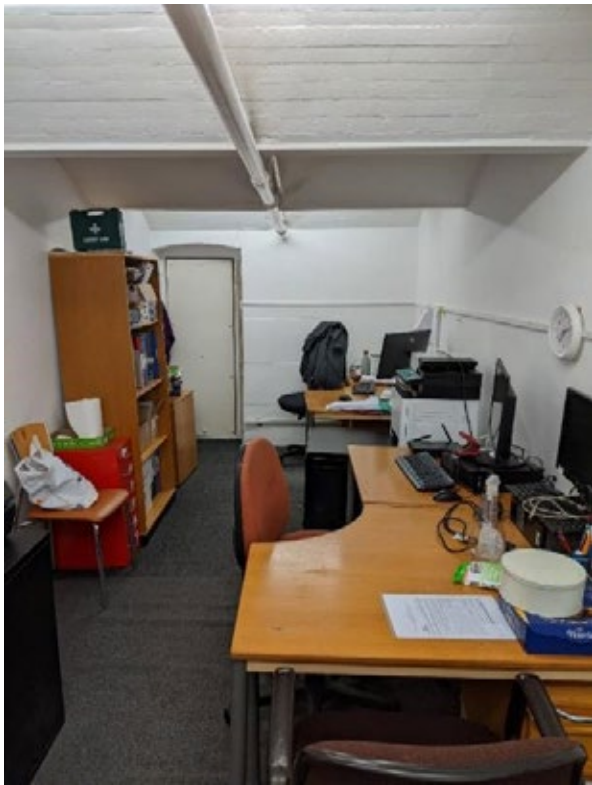
The heating system pipes are a dominant feature in Office 2 as it is suspended from the ceiling and travels from Office 1 and into Office 3 above the entrance door (Figures 59 and 60). The pipe continues to be suspended from the ceiling in GF Office 3 and into the storage area behind, which is accessed via Office 2 (Figures 61 and 62). The ceiling in Office 2 and storage area behind is brick and vaulted. The entrance door from outside and window, and their frames are timber (Figure 60). The window mullions in Office 3 are stone, with a steel casement holding the glass (Figures 63 and 64). Both windows are single glazed. There is an old steel shutter on the internal side of the window in Office 3. **This window is in a poor condition.**

Figure 61: GF Office 3

Figure 62: Storage area behind GF Office 3 (accessed from Office 2)

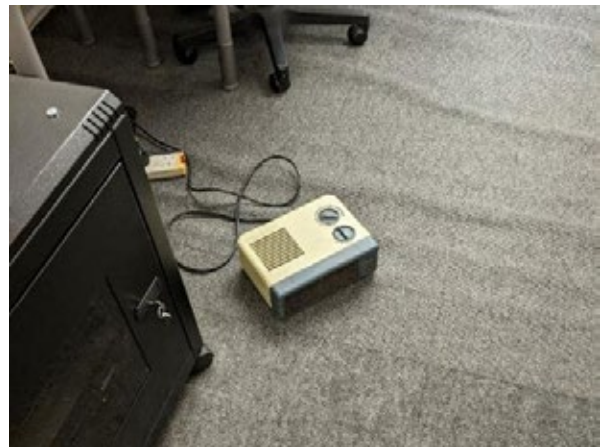
Both offices had additional free-standing portable electric heaters, which is consistent with the information provided in the preliminary BPE and occupant survey (Figures 67 and 68). These heaters were not in use at the time of collecting the data. The environmental data was recorded within two to three hours after the offices had been in use. When these offices are in use, they are open to the public. Public access to the offices is via the entrance door at the front of the building, shown in Figure 60. Although the internal temperature is higher than Office 1, this is still low given that this space had been occupied.

Figure 67: Electric heating panel in Office 2

Figure 68: Instantaneous heater in Office 2

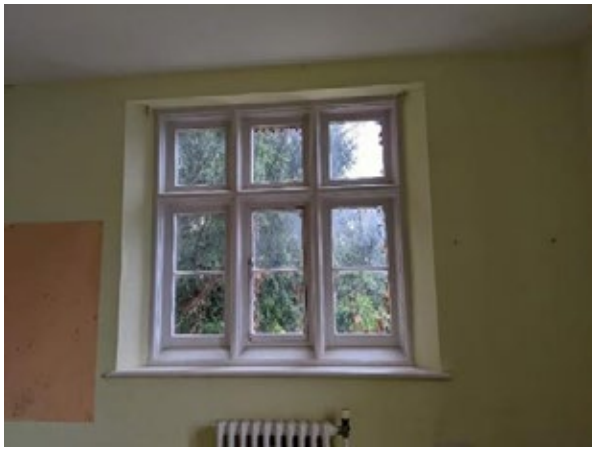
Office 4 on the first floor has two single glazed windows, one facing north on the side of the building and the other on the rear façade (Figures 111 and 112, respectively). The windows have timber mullions with metal frames. There is movement in the floor in the corner closest to the external wall and partition wall with FF Office 5 (Figure 113). **The ceiling has a large area of missing plaster, likely caused by it having got wet and falling away from the laths (Figure 114).**

Figure 111: North facing window in FF Office 4

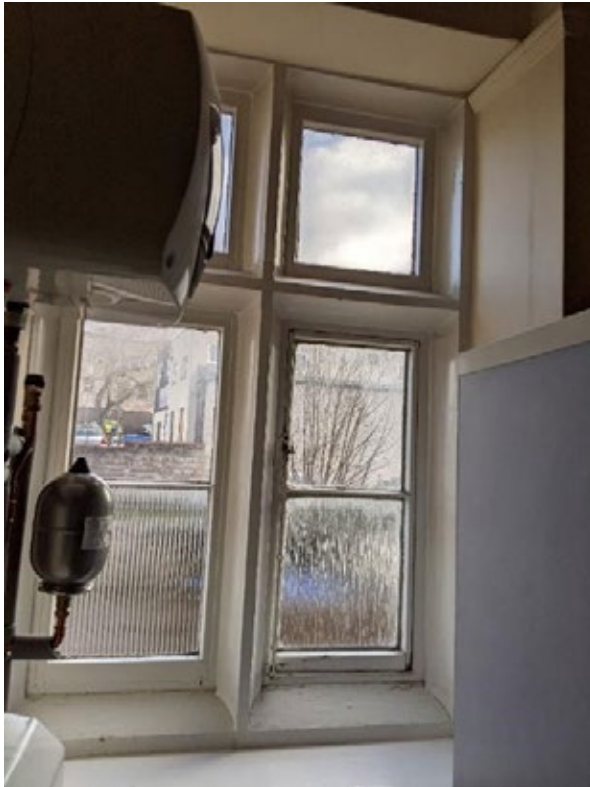
The window in the first floor WC is single glazed with timber mullions and frames (Figures 131). **There is a crack in the frame, large enough for light to get through** (Figure 132).

Figure 131: FF WC window

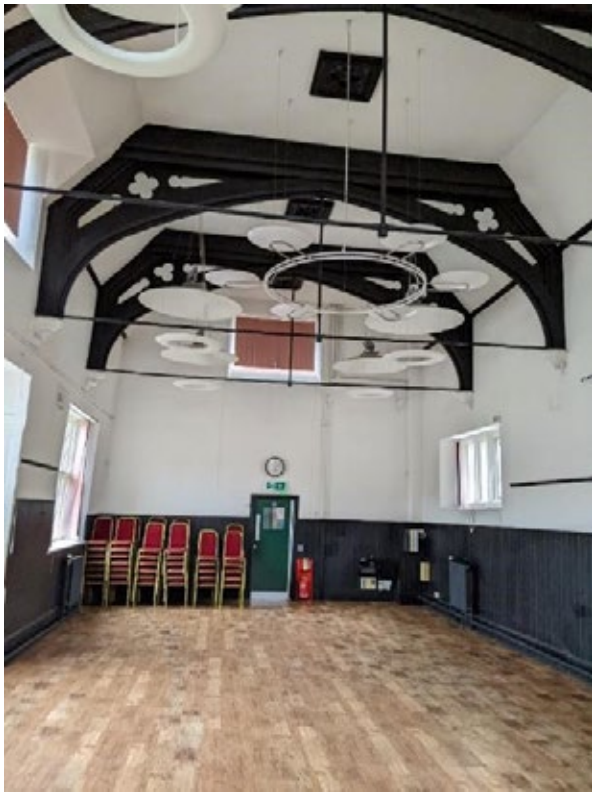
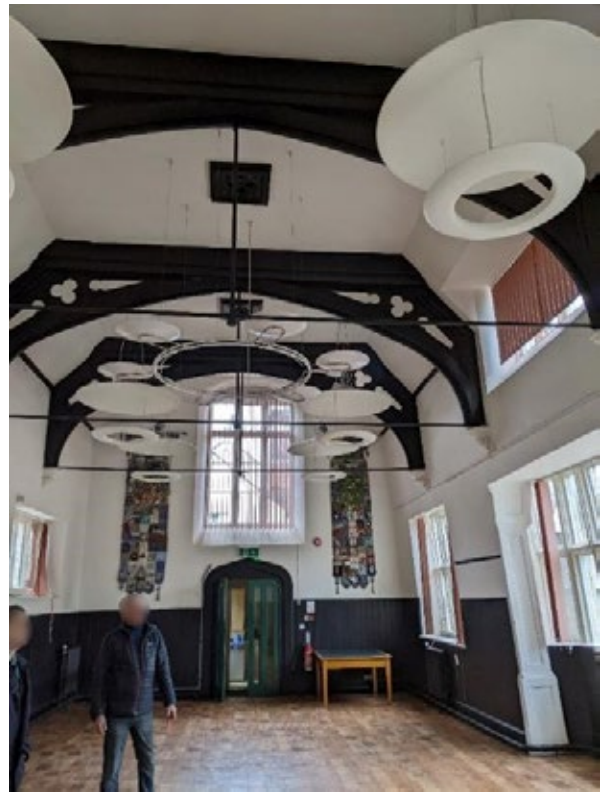
The meeting room (hall) is the main internal space of the original 16th Century building. It is a large space with a very high ceiling and visible ornate trusses. Although not completely visible, the roof structure appears to be a crown post roof truss with metal tie bar system (Figures 133 and 134). There is a large window in the south gable wall (Figure 135) and a smaller window in the north gable wall. The front façade has four large windows, and the rear has three slightly smaller ones. The windows are single glazed in stone mullions and metal frames. The mullions and frames appear to have been painted in a **glossy paint, that has now failed** (Figures 137 to 139). There are **water runs from the bottom of the top window**, above the main front window in the centre of the wall (Figure 140).

Figure 133: Meeting room (main hall)

Figure 134: Meeting room (main hall)

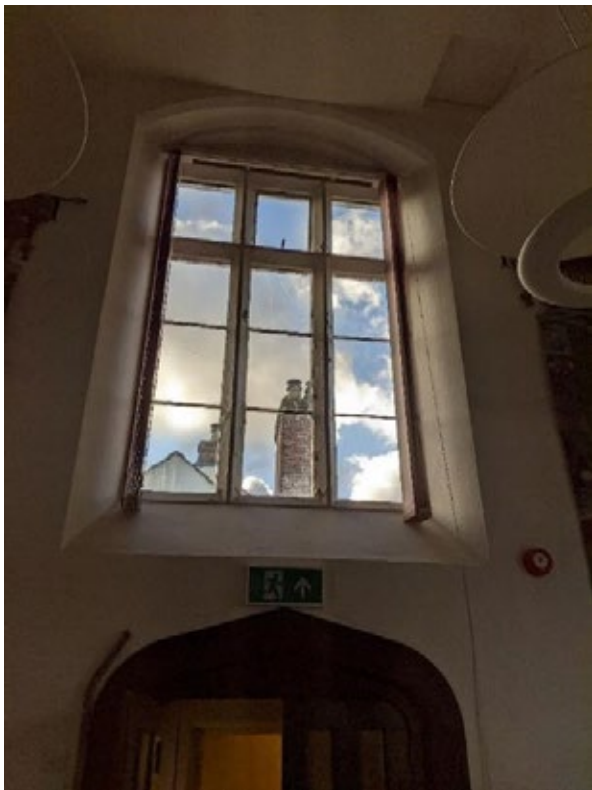
Figure 135: Window above door to kitchen from the meeting room

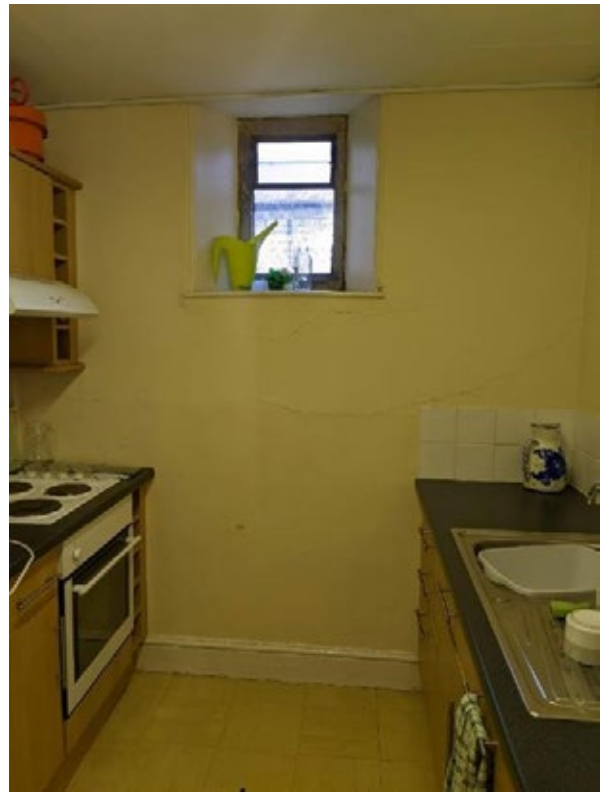
The kitchen is located above the external walkway and is accessed via an unheated space next to the meeting room. Opposite the entrance is a party wall, joining the building on the south of the Old Town Hall. The kitchen has a range of cupboards, a fridge, cooker with hood and sink (Figures 151 and 152).

Figure 151: Fridge, cupboards, and rear window in kitchen

Figure 152: Small kitchen in the front (west) facing wall

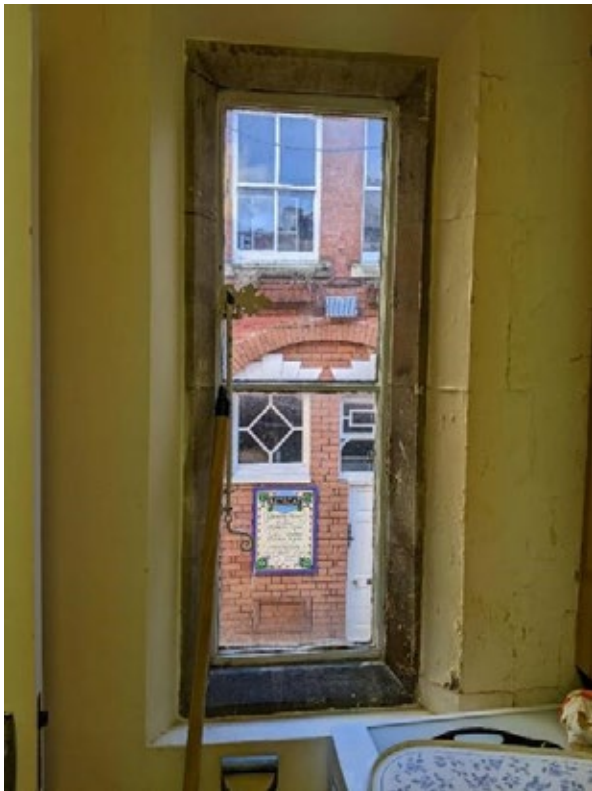
There are **significant signs of water ingress, evidenced by the blistering and salt crystallisation on the surface of the walls.** This is particularly significant on the southern side of the rear window and behind the fridge (Figures 153 and 154). The walls appear to have been covered with impervious gypsum plaster and paint. These areas are consistent with the evidence of moisture with the growth of vegetation in the external areas. **The general condition of the meeting room appears to be very poor.**

Figure 153: Kitchen window in the rear (east) facing wall

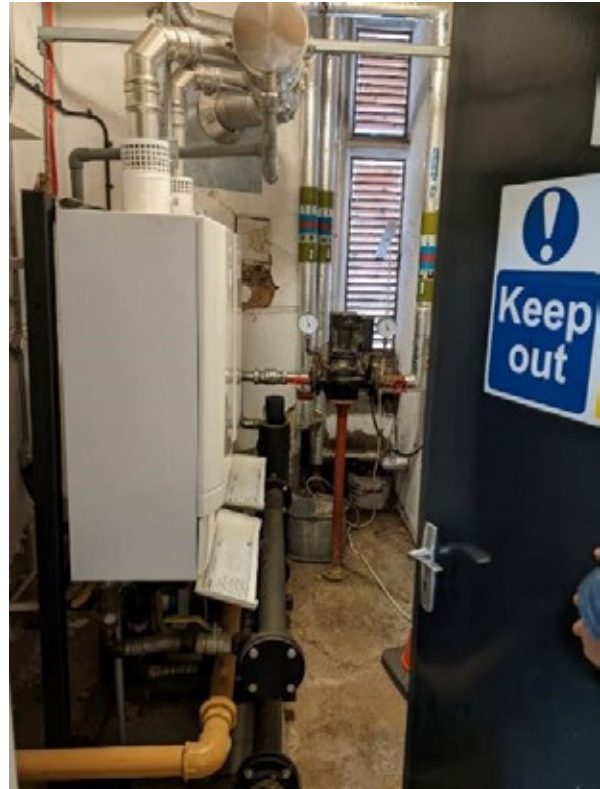
Figure 162: Plant room

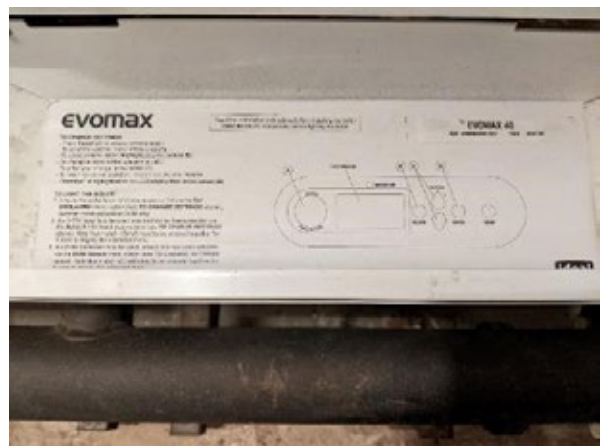
Figure 164: Boiler information

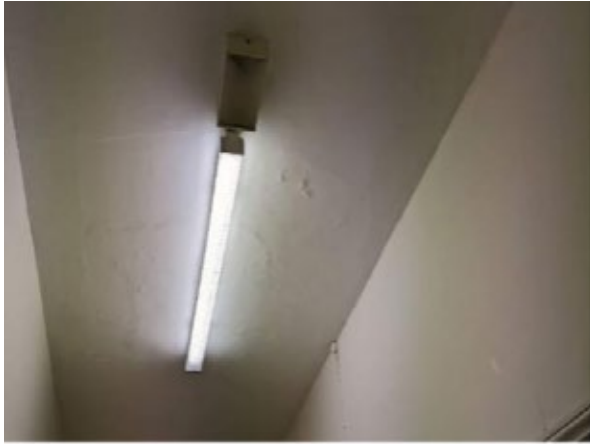
Figure 171: Single 5' T8 light fitting

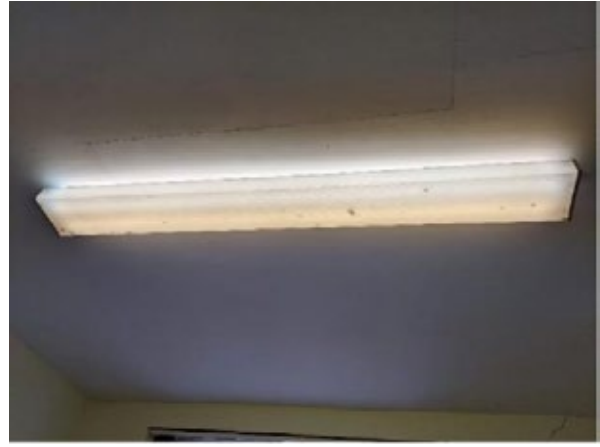
Figure 172: Double 5' T8 light fitting
